Inspection Report

Property Address:
1 Happy Trails
Pleasantville FL

1st Choice Inspectors LLC

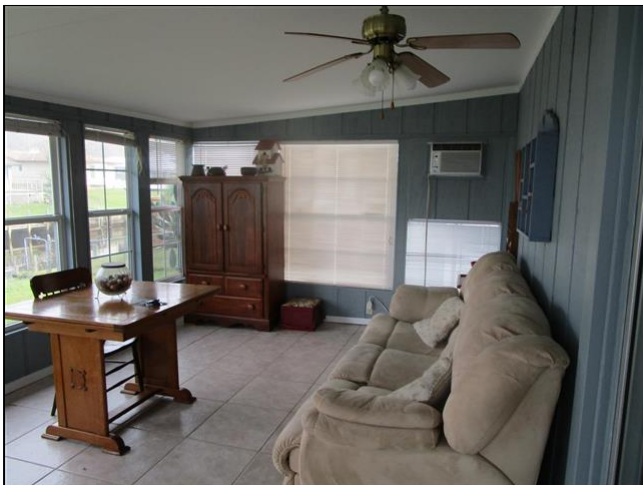
1.0 Item 1(Picture)

Visibility and access to some areas was limited due to occupancy. (Furnishings, appliances, stored personal items, etc.)

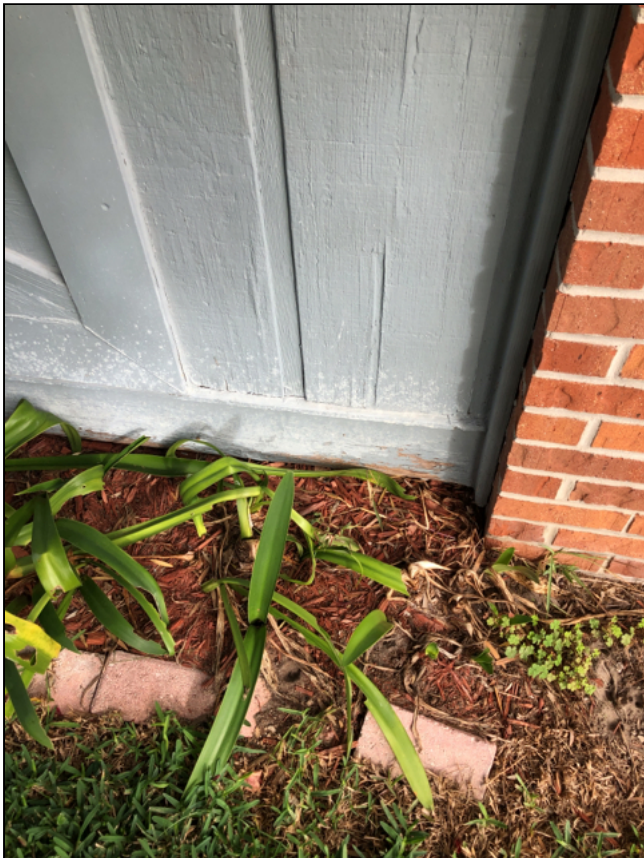
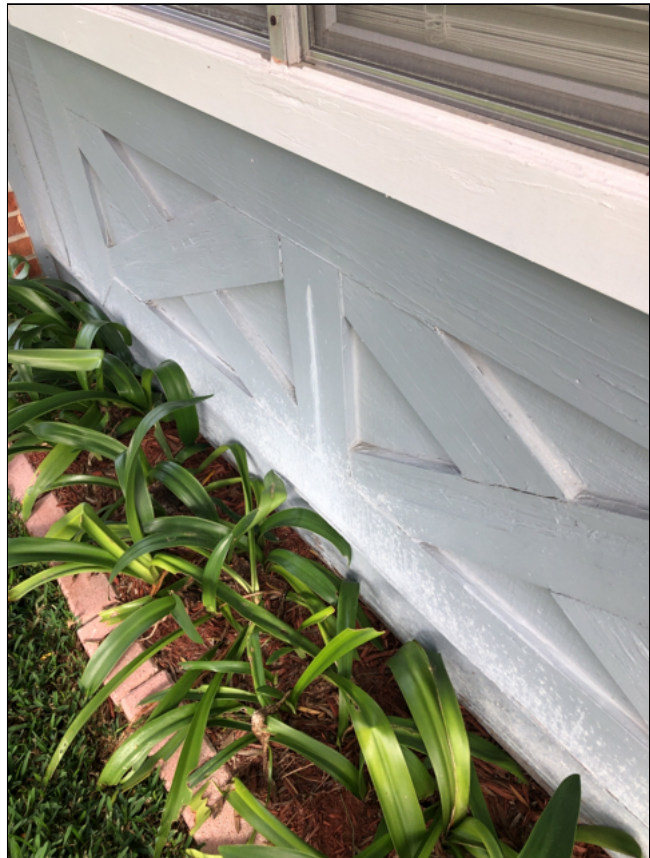
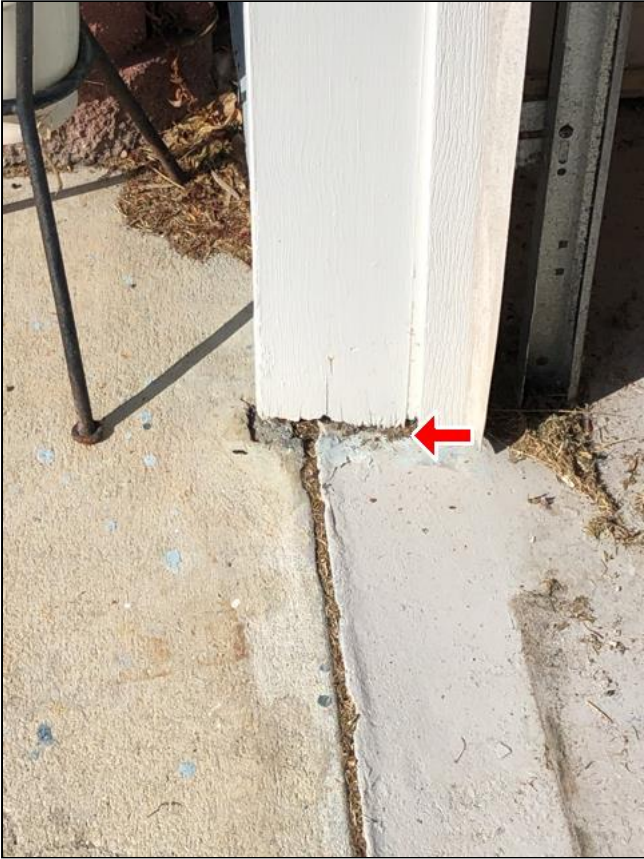
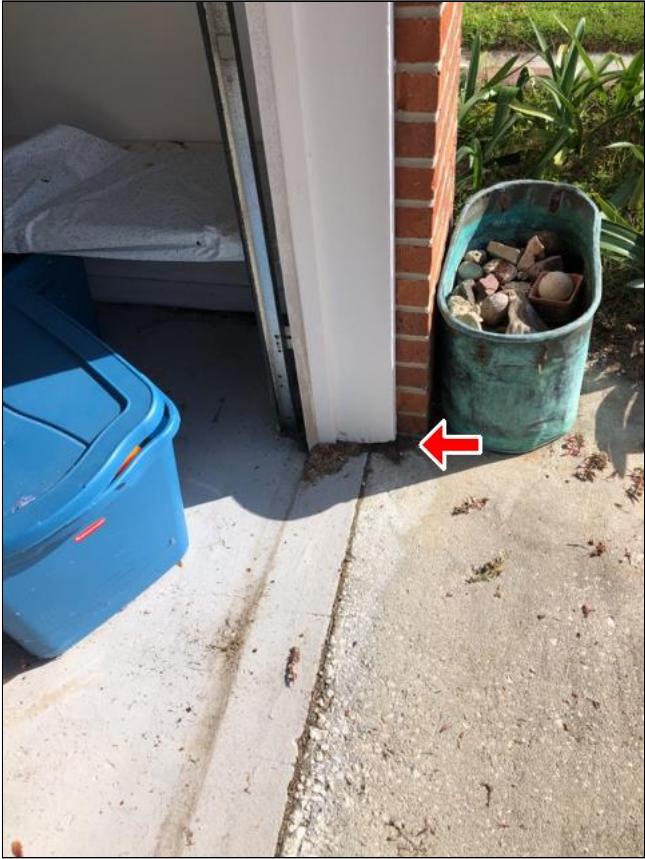
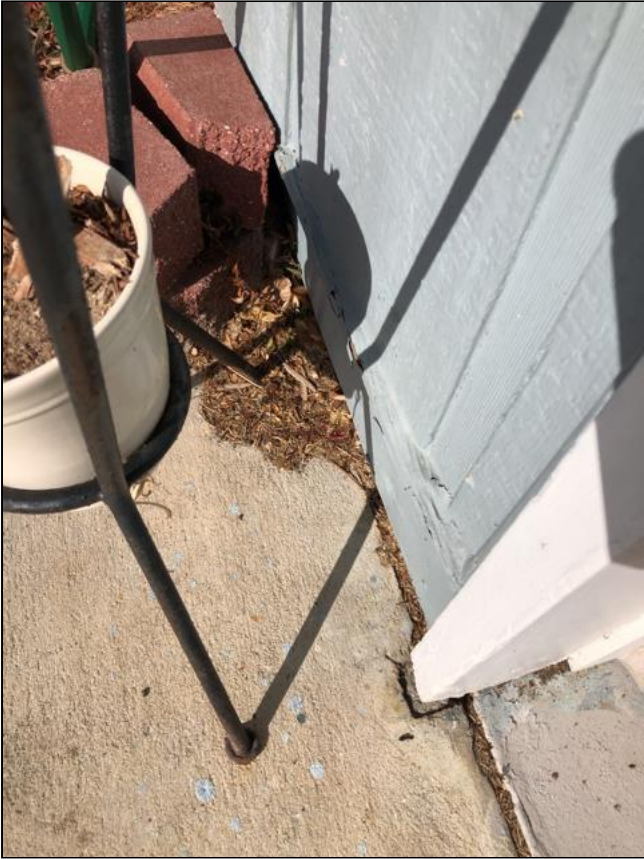
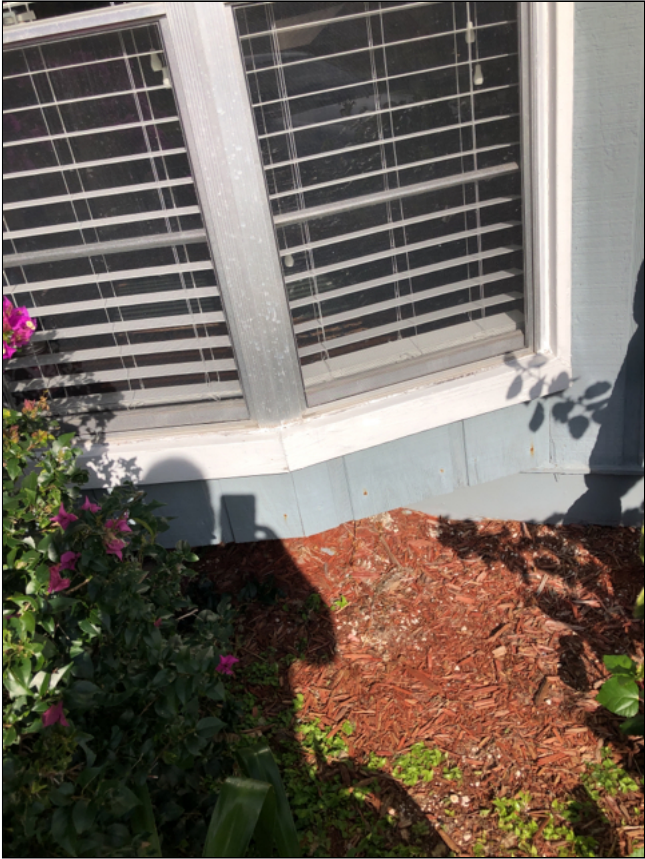
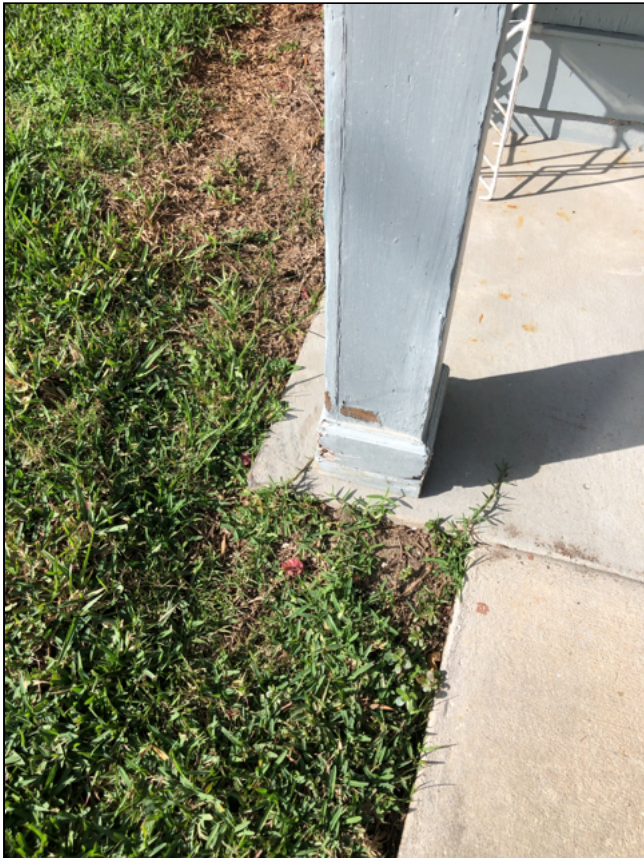
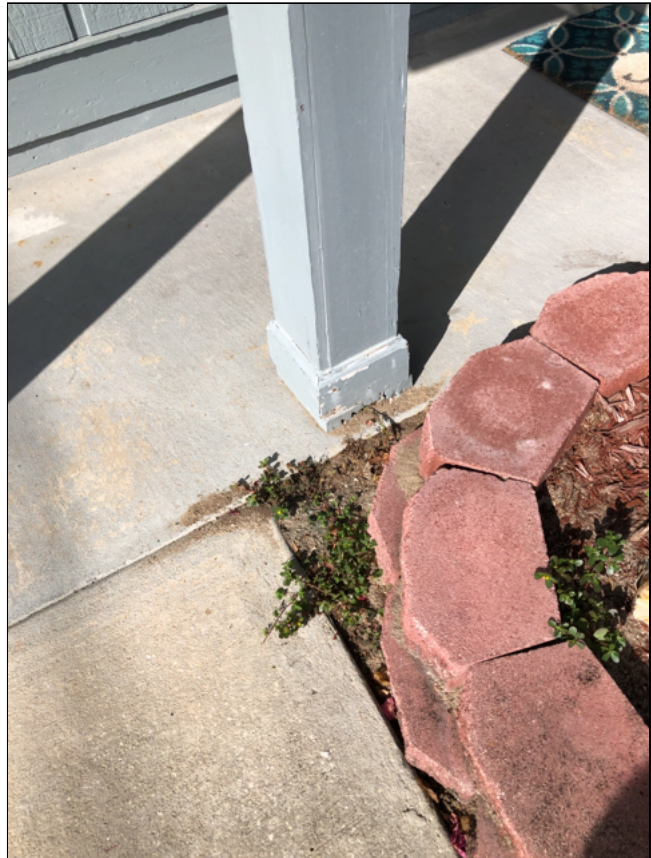
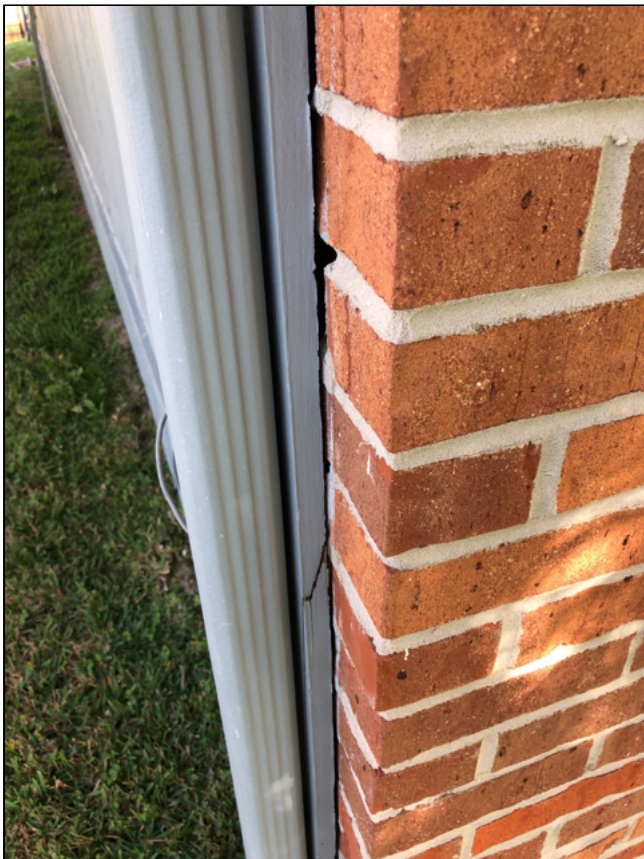
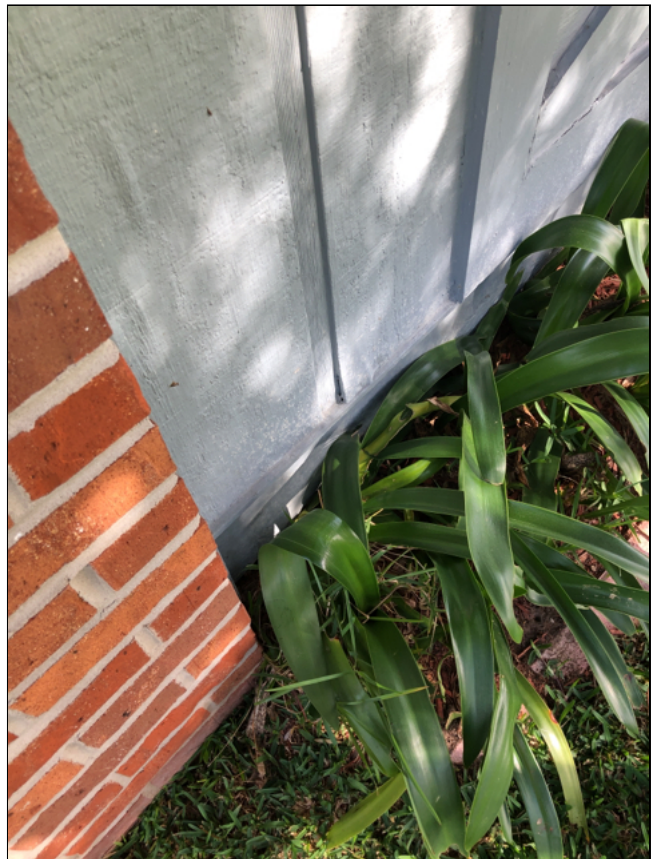
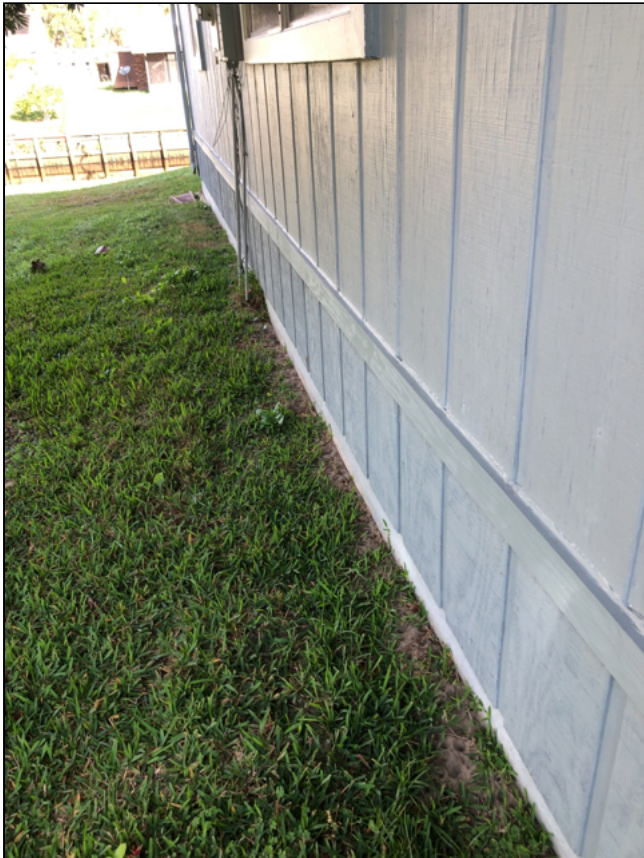
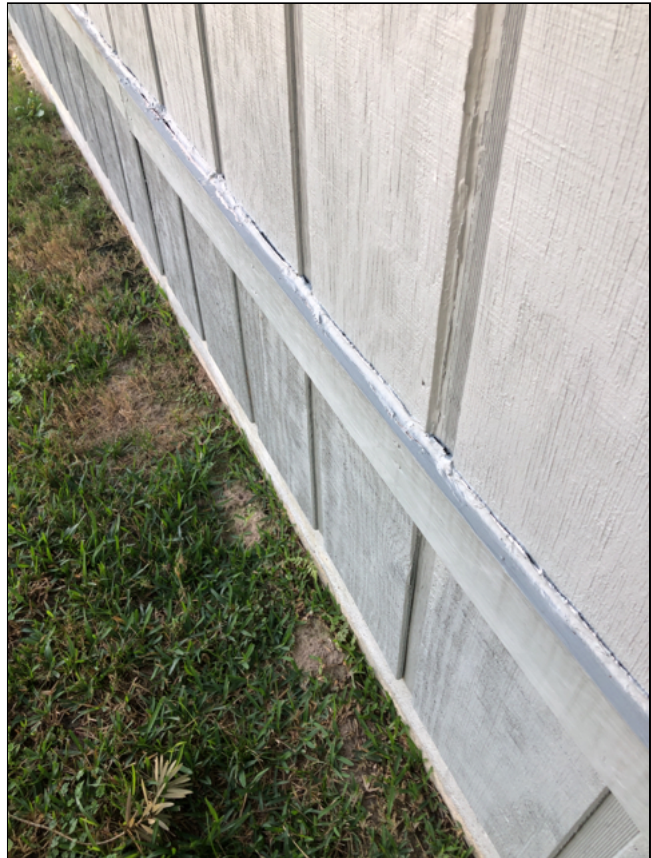
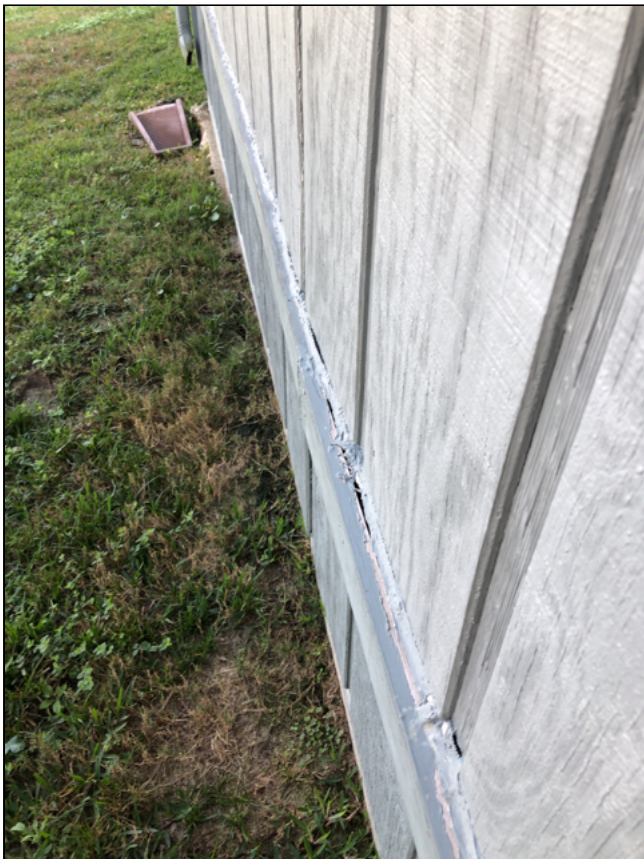
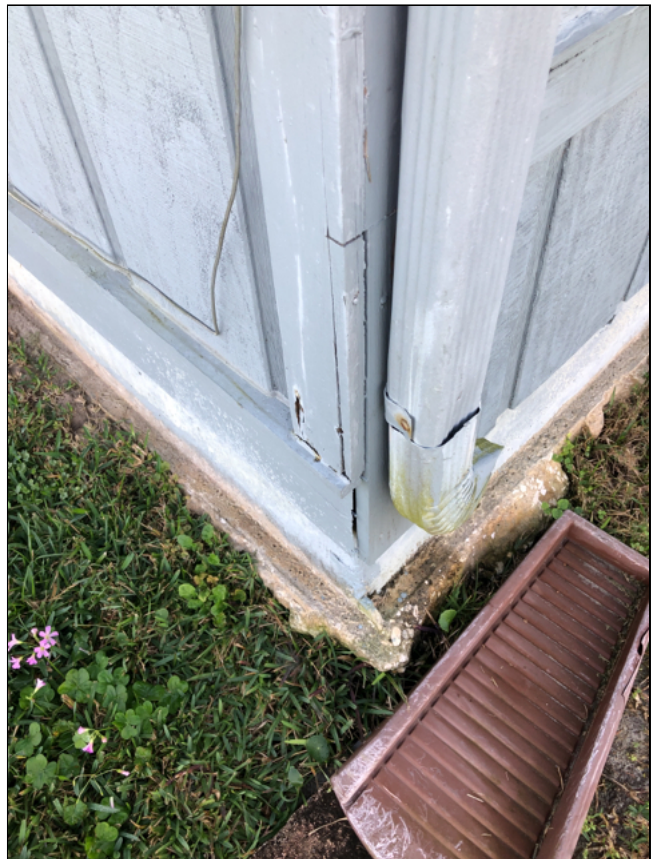
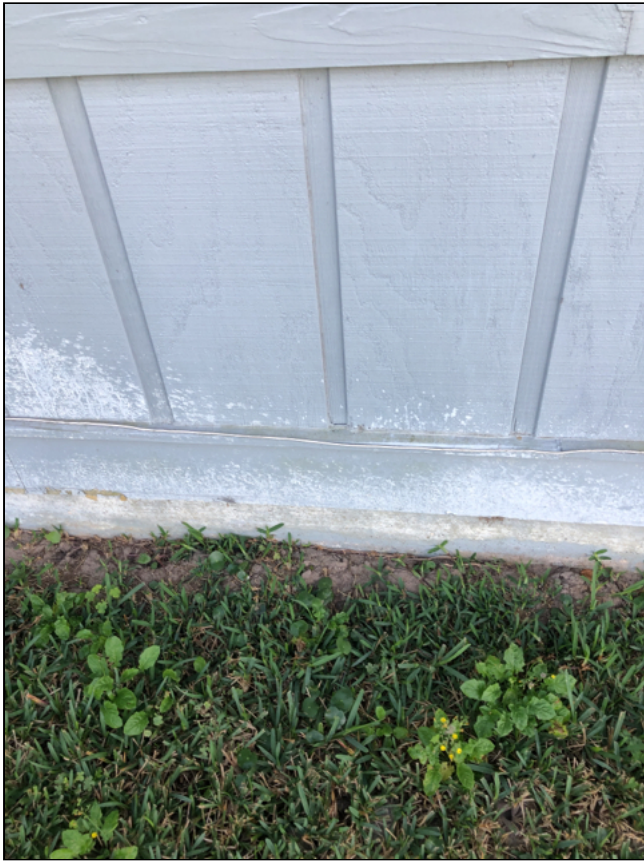
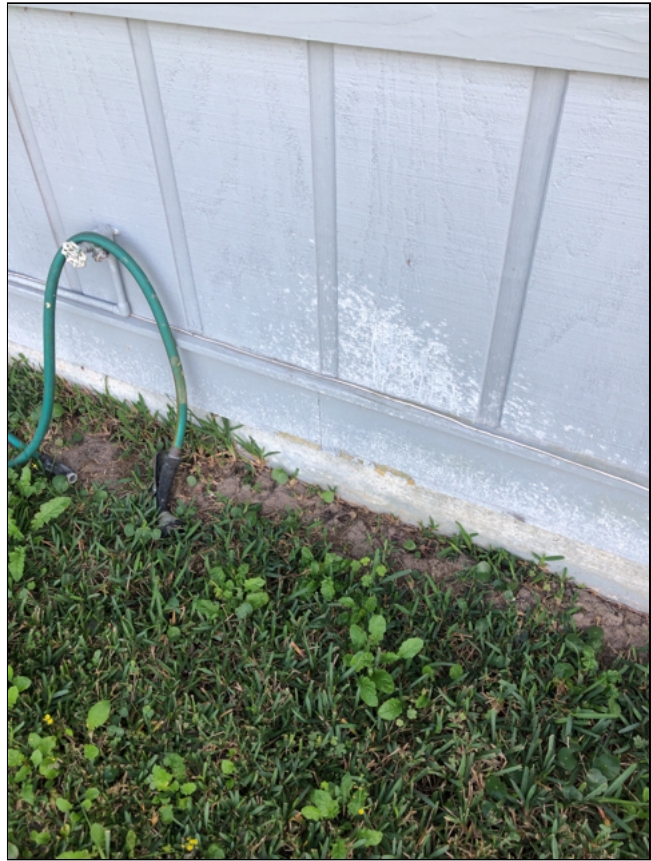
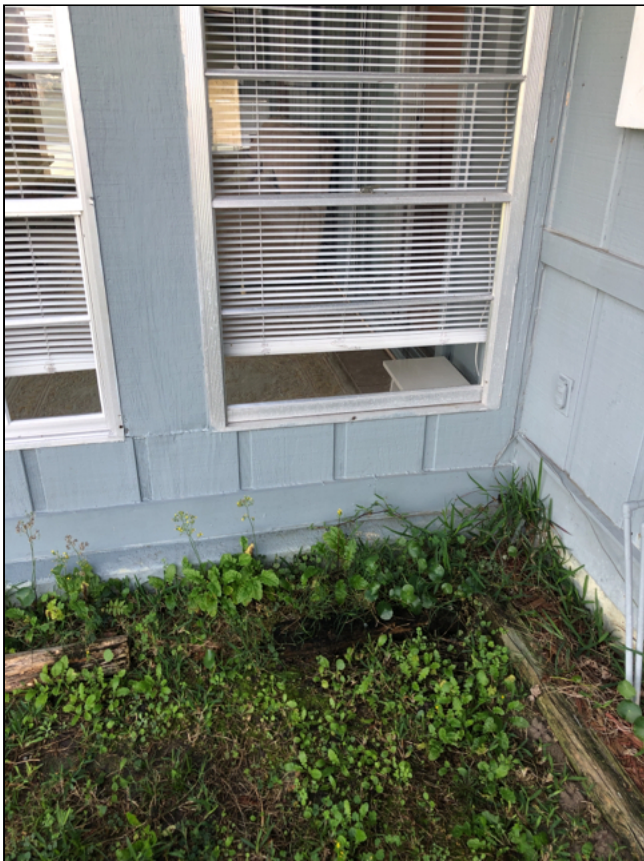
Cracks, holes, gaps, etc., on the exterior should be sealed to prevent water intrusion.

Wood rot or damage observed in multiple areas.

Some paint is failing on the exterior of the home. It needs preparation and paint.

Please refer to your Termite/WDO report for further information.

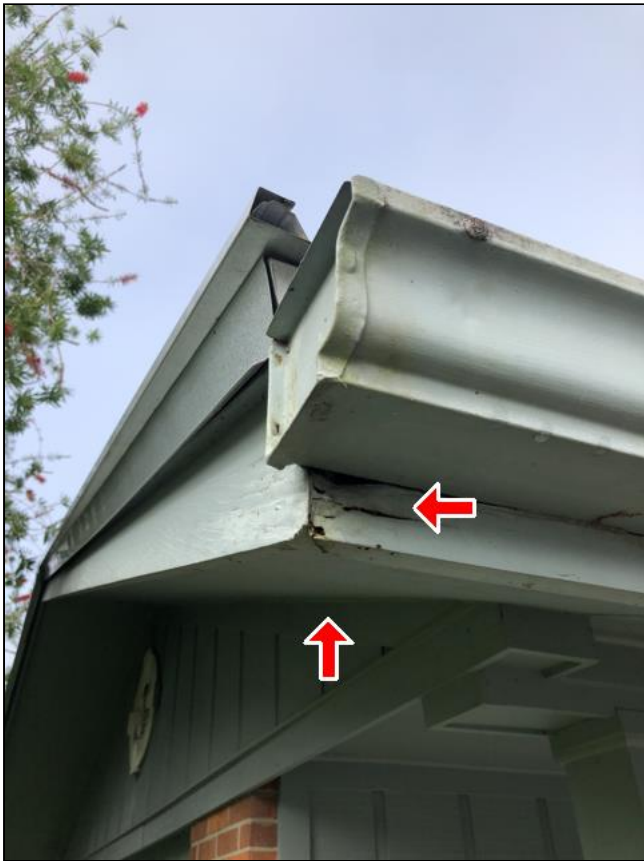
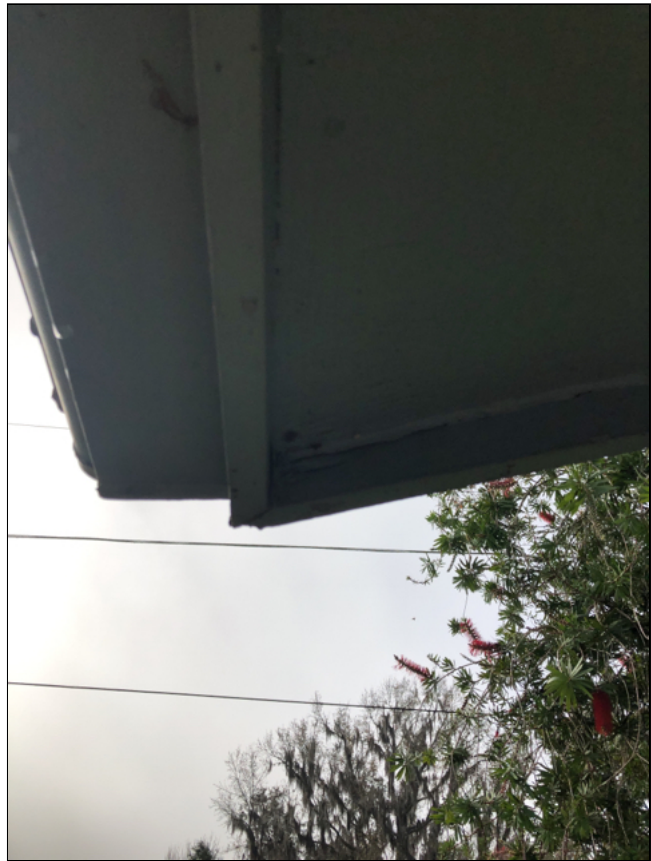
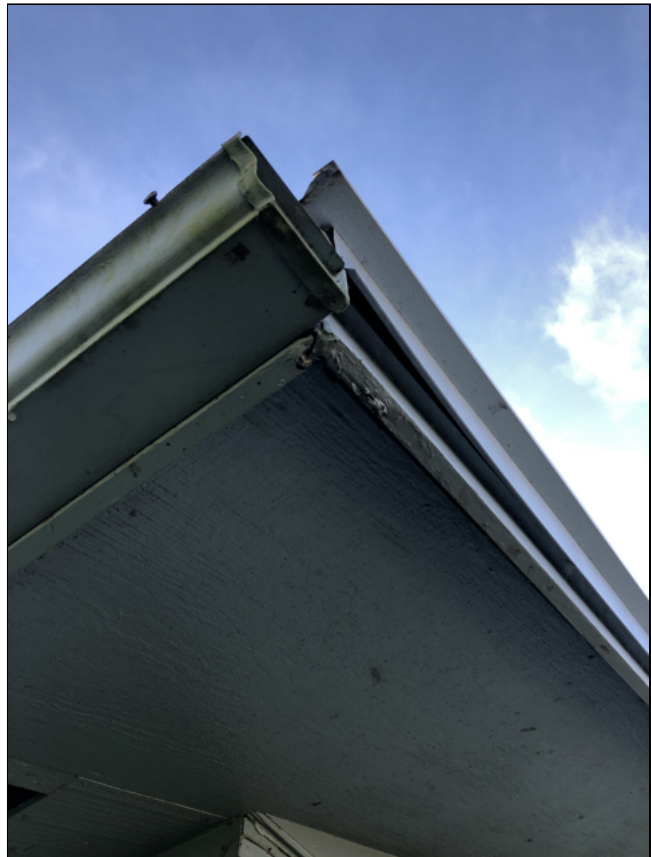
Wood rot or damage observed in multiple areas.

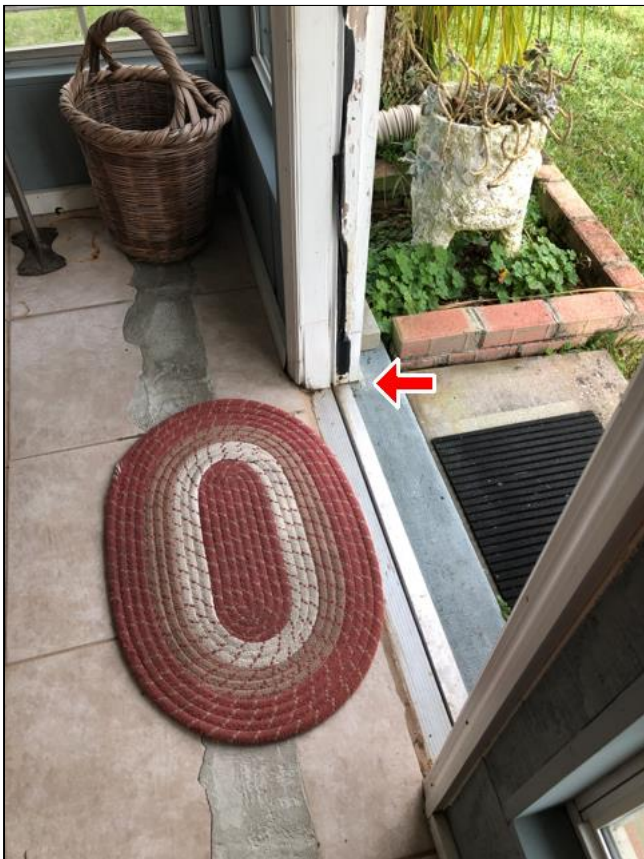
1.3 Item 1(Picture)

Comments: Inspected
Small amount of wood rot or damage observed.

Garage door on the east side needs to be adjusted to open and close correctly.

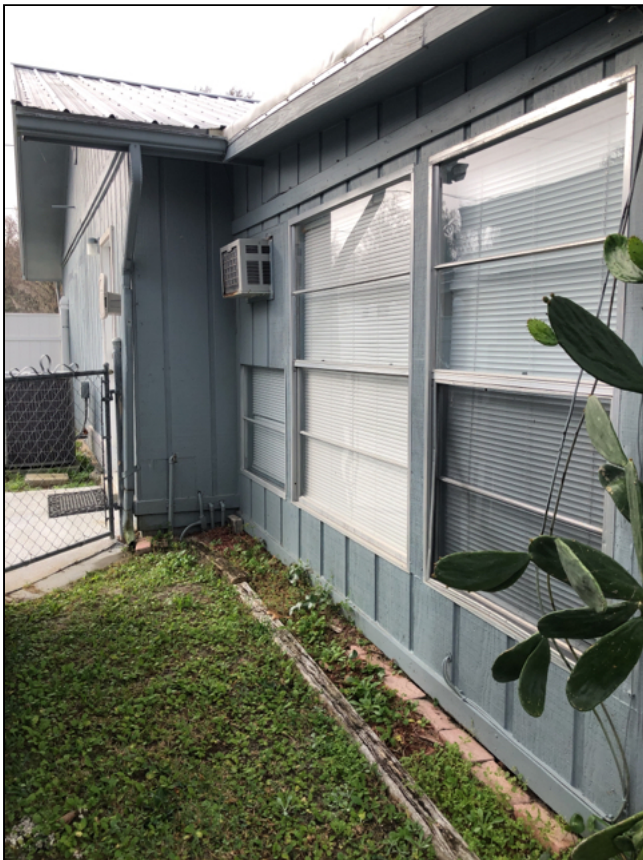
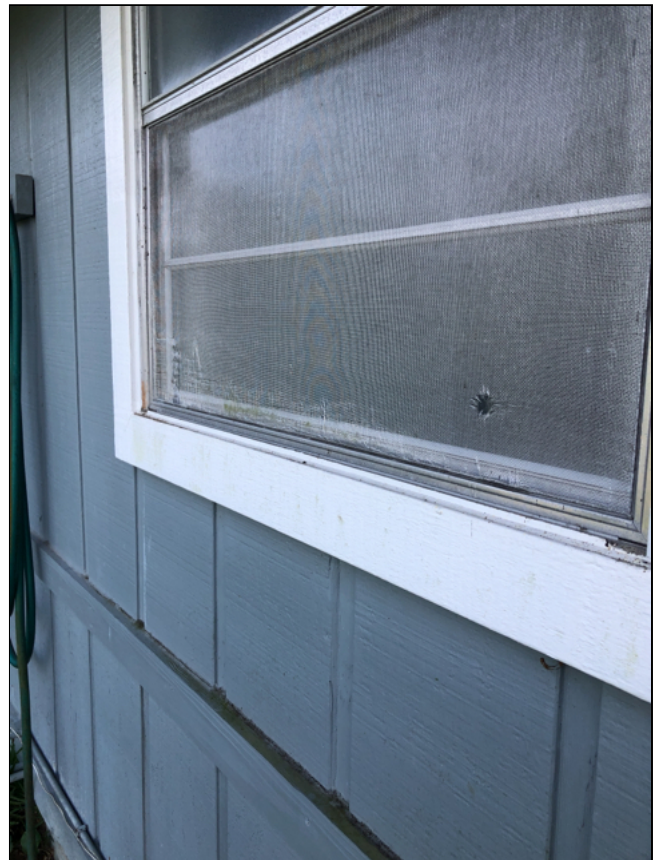
Some of the windows were missing screens.

Some of the windows have worn/torn screens that are in need of repair.

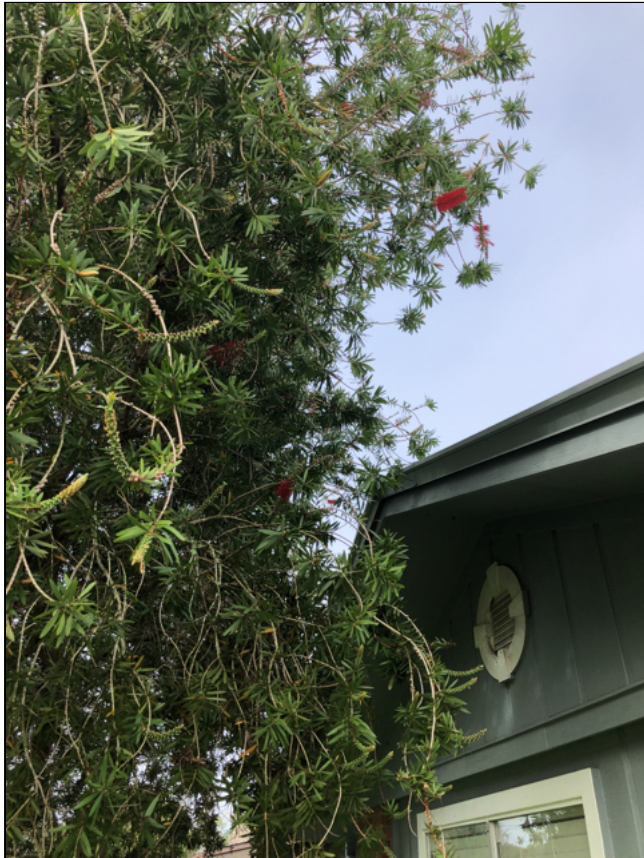
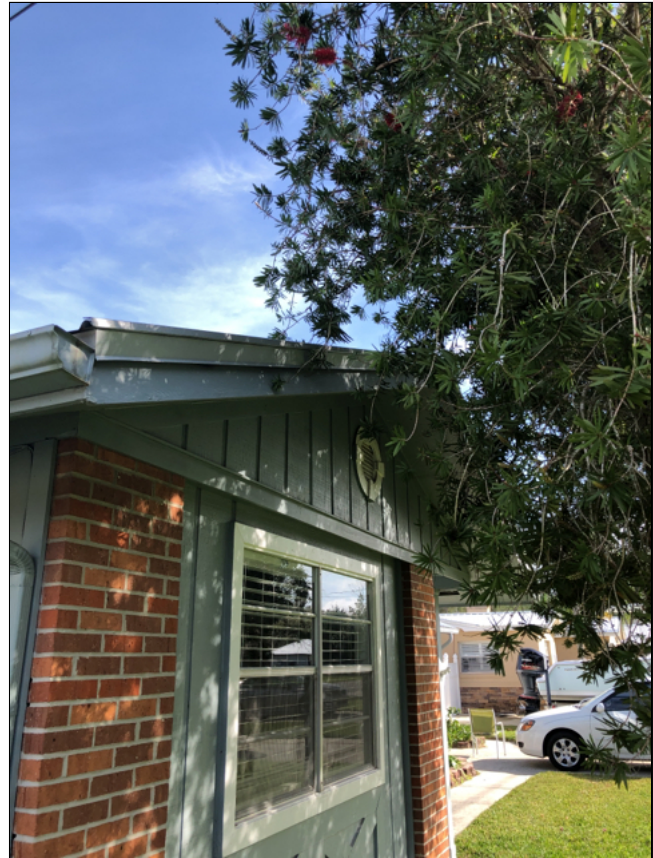
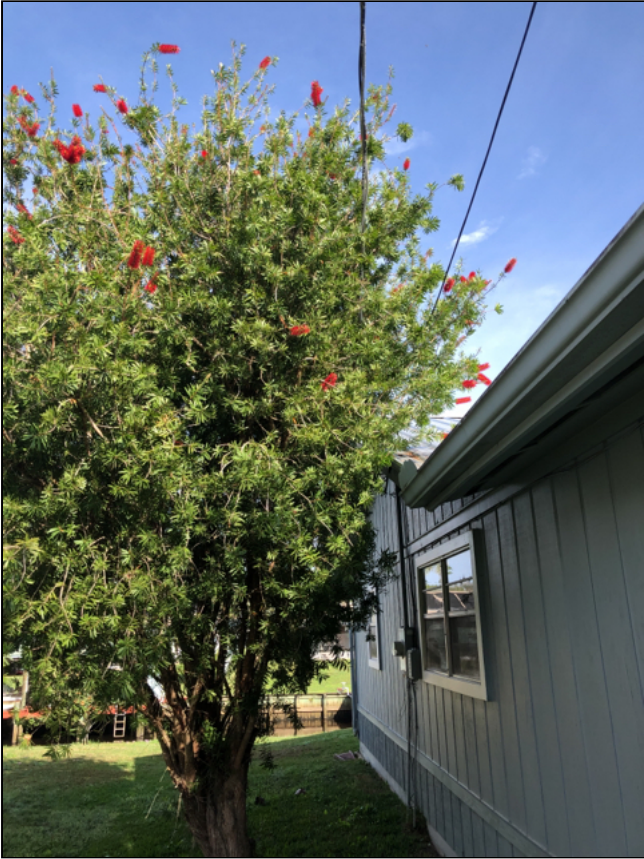
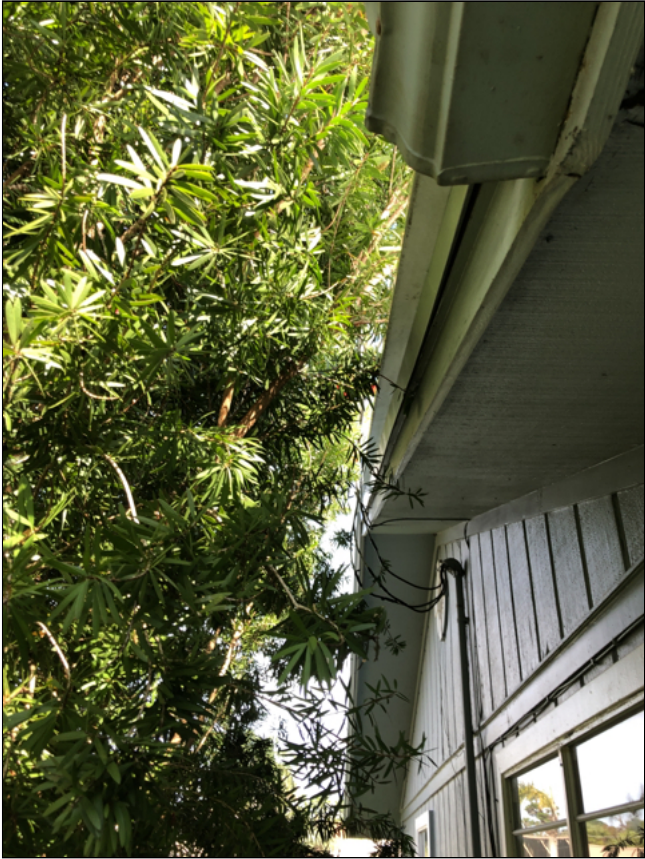
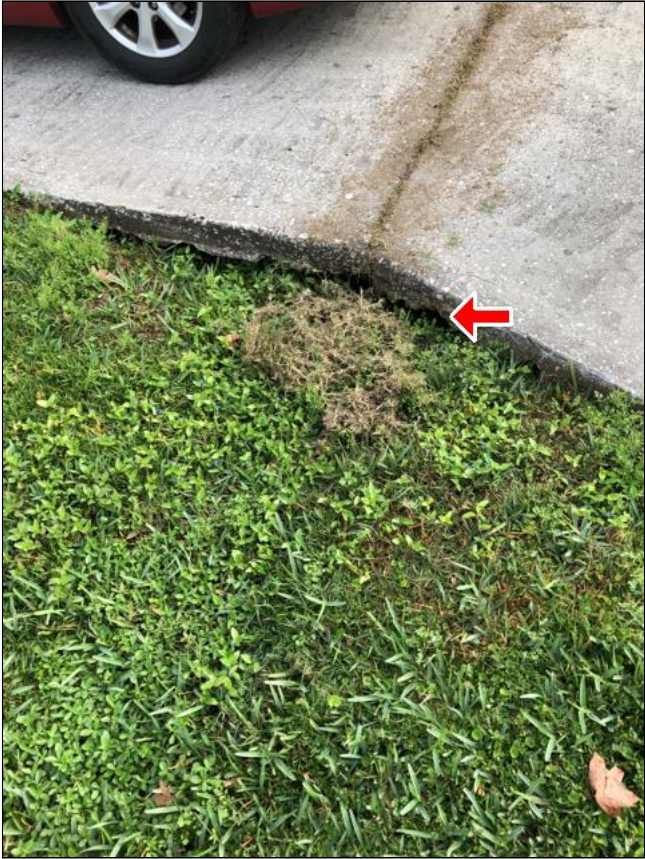
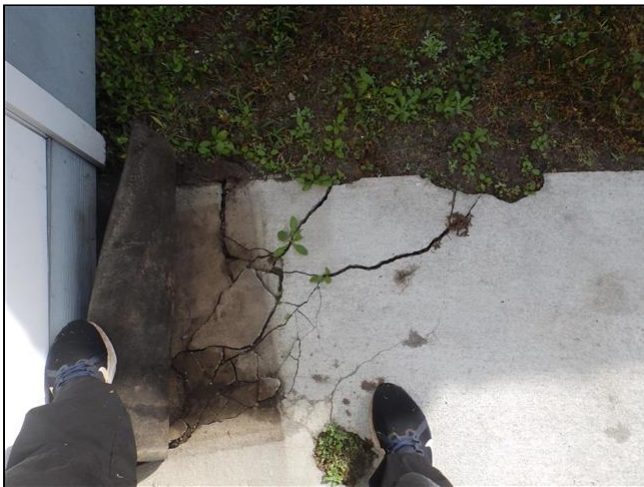
There is vegetation in contact or too close to the home. This can cause water damage, allow vermin to enter the structure or cause structural damage. Inspector recommends it be removed or trimmed.

Small amount of erosion at the driveway.

Uneven areas can be a trip/safety hazard.

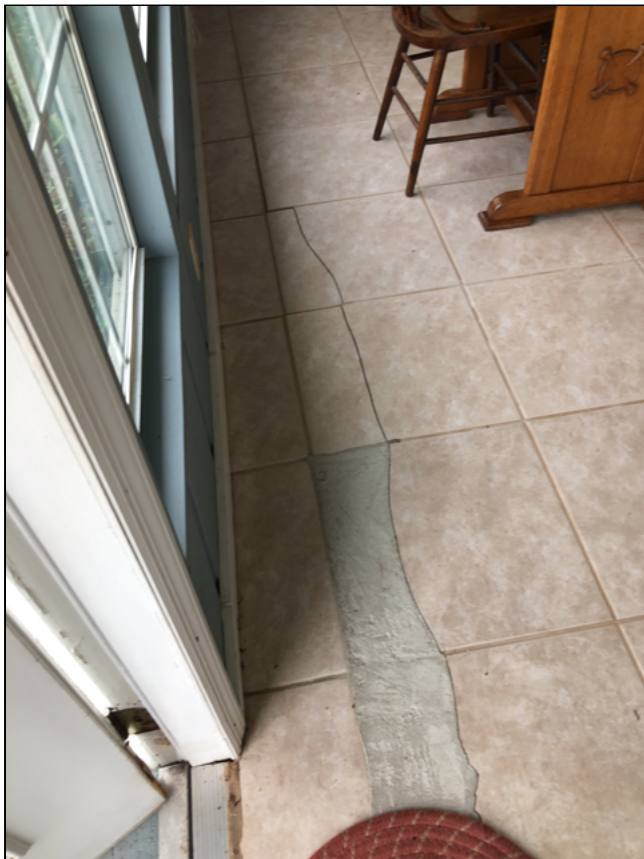
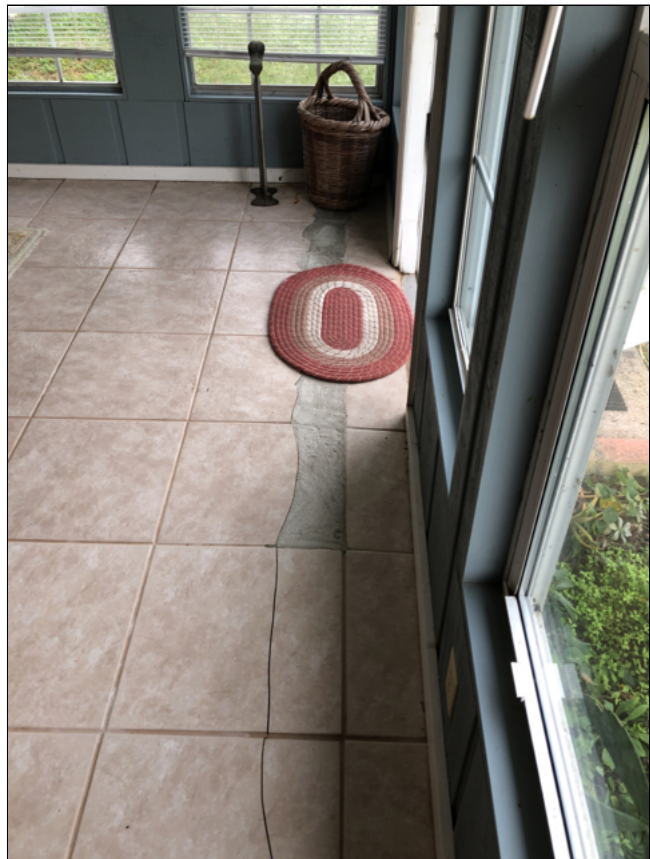
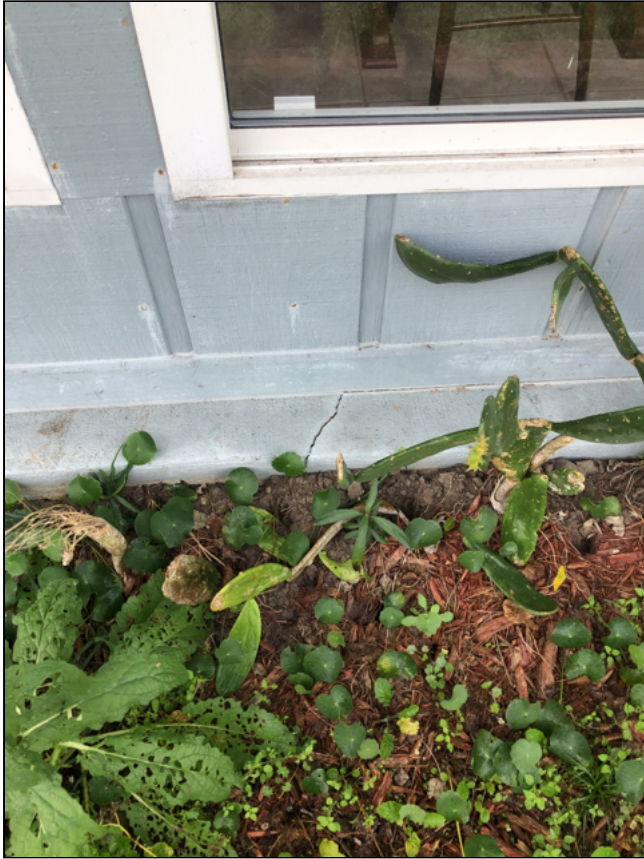
Foundation on the Florida room (north side) has settled.

Inspector recommends further evaluation by a licensed contractor.

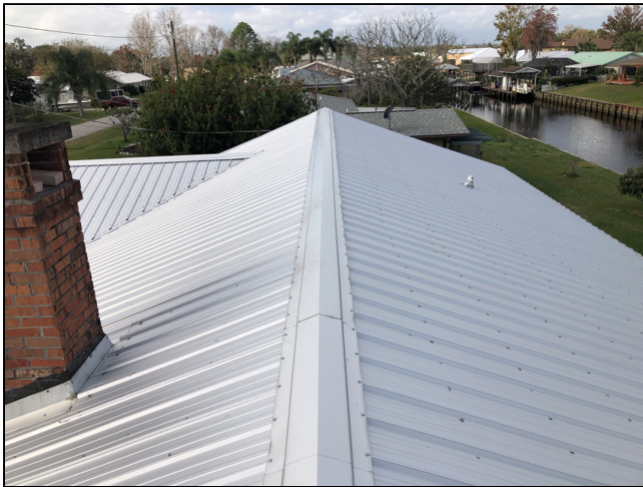
3.0 Item 1(Picture)

It appeared that the roof has at least one layer of shingles under the metal covering.

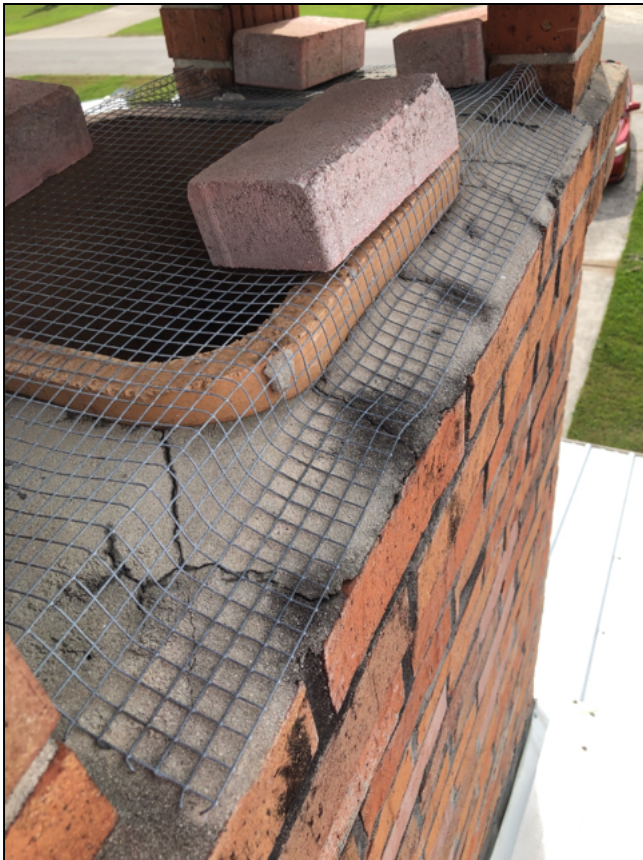
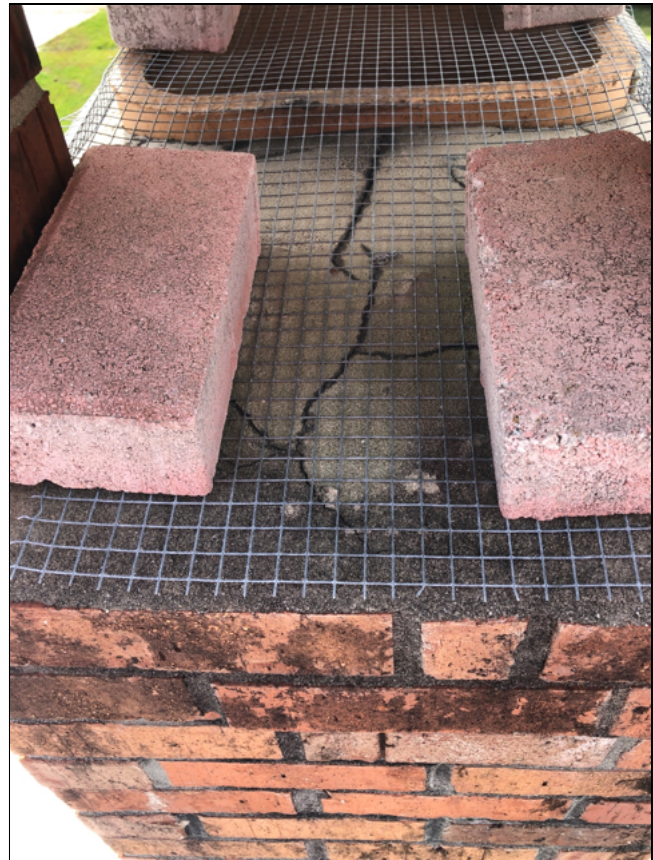
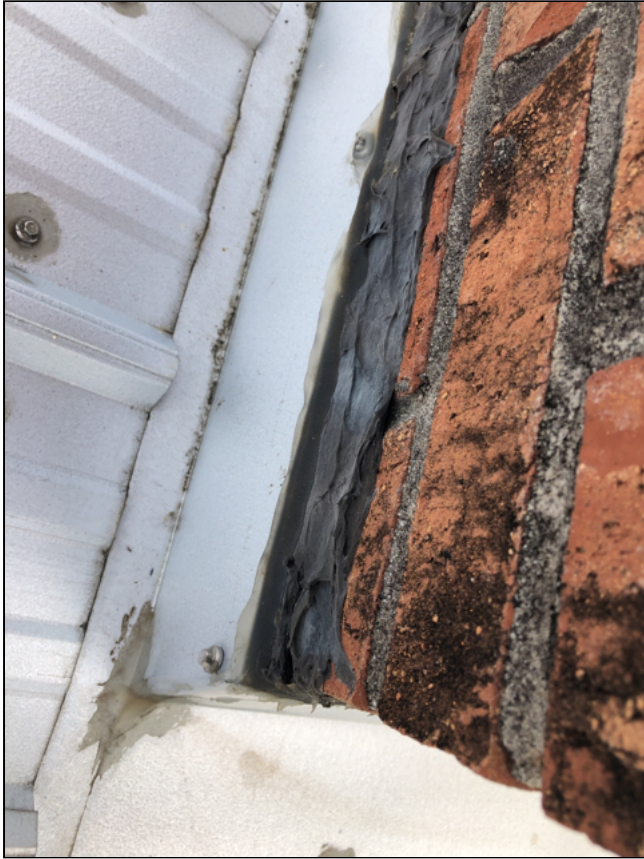
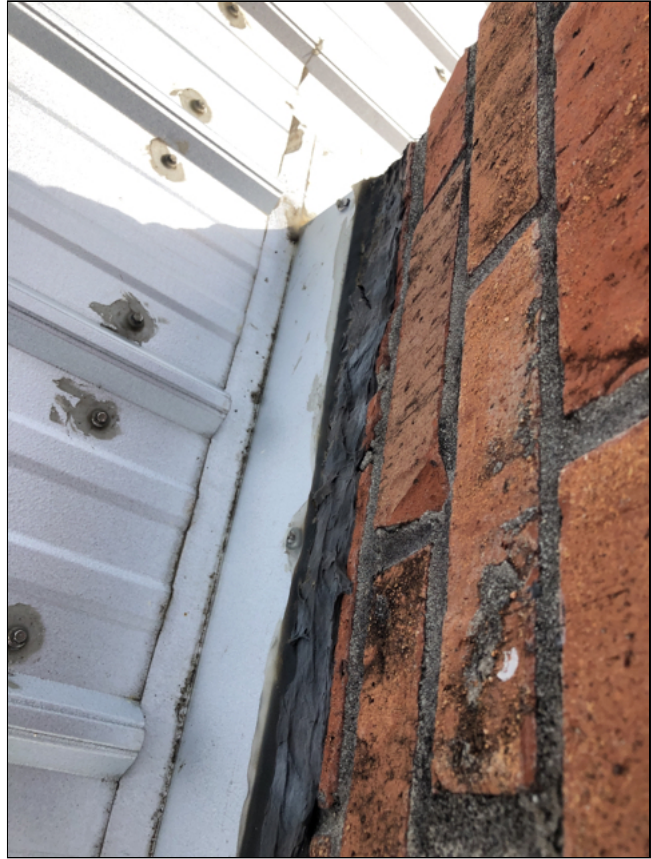
Chimney crown is cracked.

Sealant around the chimney is deteriorating in a couple of areas.

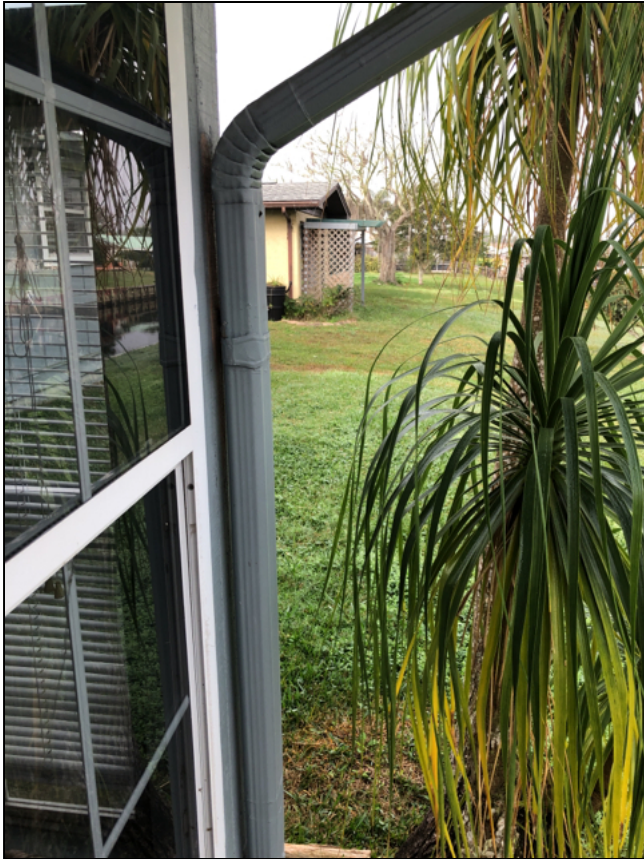
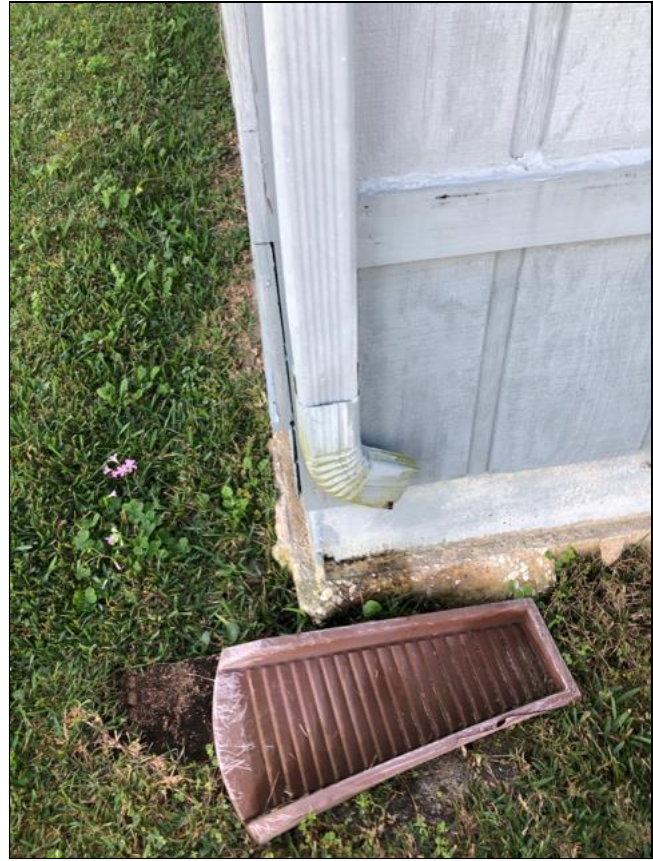
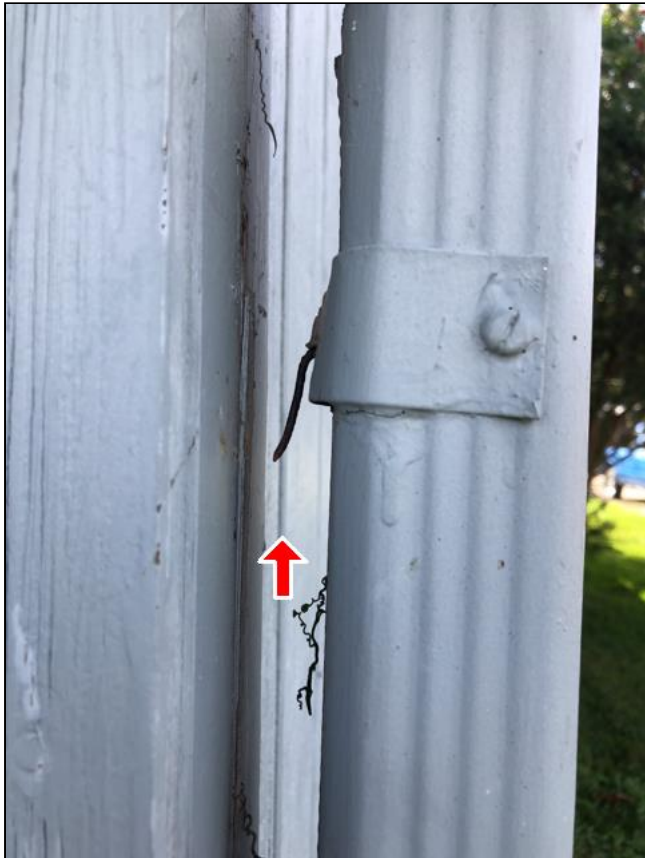
(1) Some of the downspouts are loose.

Small leak.

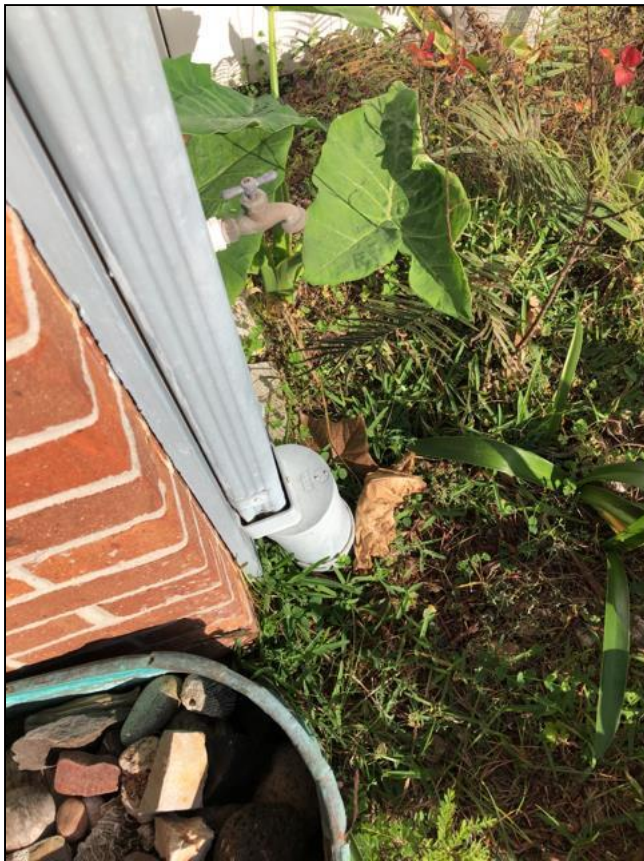
3.3 Item 8(Picture)

(2) There are below ground drain lines for gutter downspouts.

Inspector is unable to determine if drains will function properly.

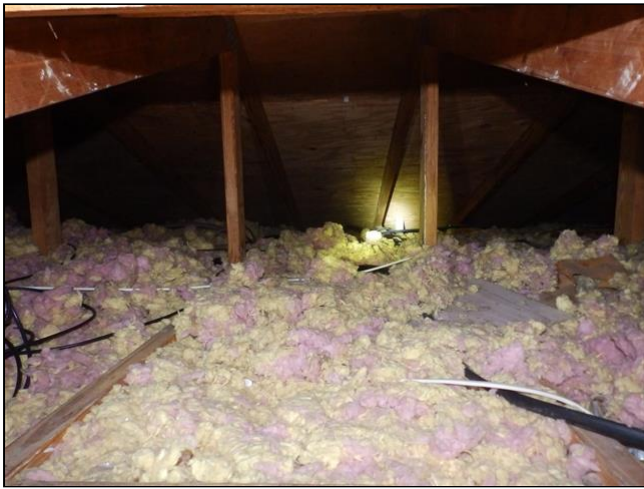
4.1 Item 1(Picture)

Average thickness of insulation in the attic was approximately 4 to 6 inches.
