Inspection Report

Property Address:
1 Happy Trails
Pleasantville FL

1st Choice Inspectors LLC

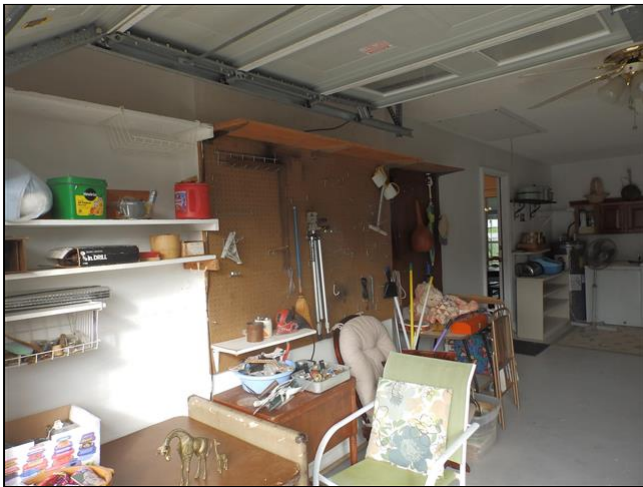
5.1 Item 1(Picture)

Garage was only partially visible due to occupancy. (Furnishings, appliances, stored personal items, etc.)

Garage walls were covered with paint. Therefore, it could not be determined if the drywall was fire rated.

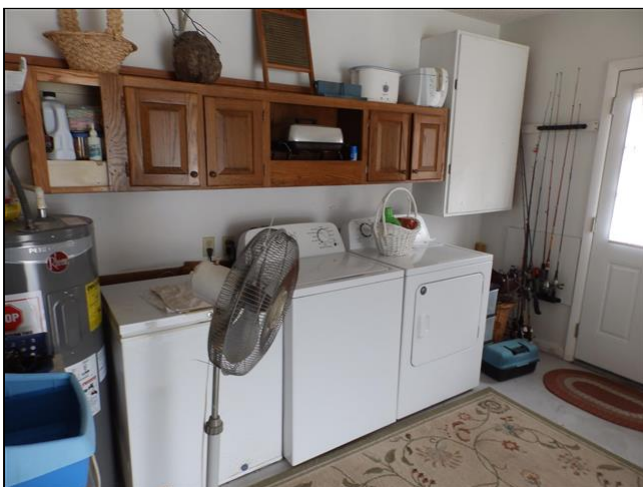
5.2 Item 1(Picture)

Garage was only partially visible due to occupancy. (Furnishings, appliances, stored personal items, etc.)

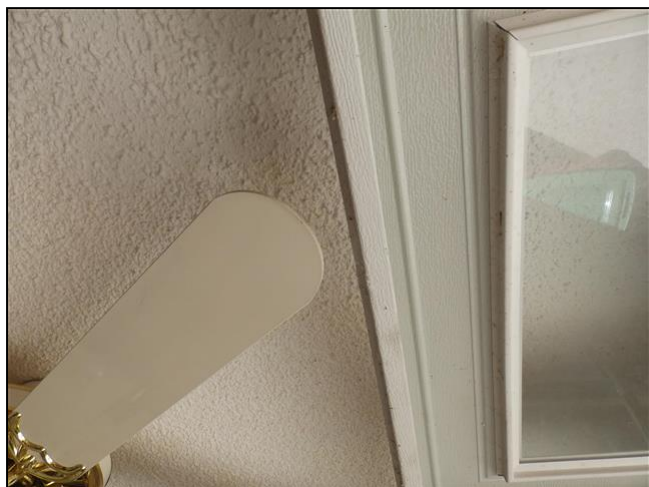
5.3 Item 1(Picture)

Garage door hits the ceiling fan if opened too far. Recommend that the ceiling fan be moved.

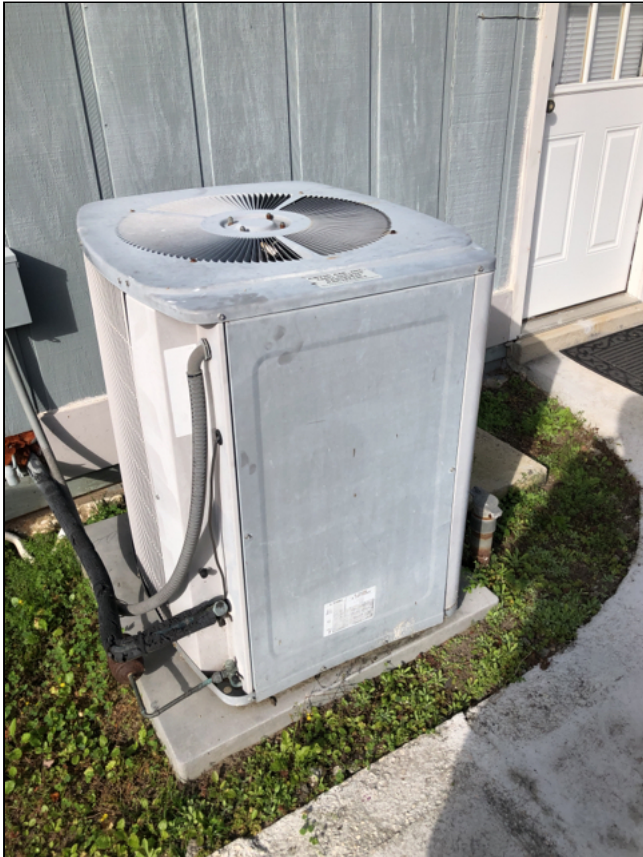
6.0 Item 1(Picture)

Heating/cooling system is a heat pump forced air system. This means that the same system that supplies heat also supplies cooling. The heating system was not tested due to the fact that the outside temperature was above 65 degrees Fahrenheit and it is recommended that the heating system not be run when the outside temperature is above 65 degrees Fahrenheit. Since the same HVAC system supplies both heating and cooling, it is assumed that if the cooling system works then the heating system also works.

HVAC system age estimated at years. Life expectancy is generally 10 to 15 years. Therefore, the HVAC system may need to be replaced within the next 5 years.

Air handler age estimated at 20 years.

HVAC condenser age estimated at 20 years.

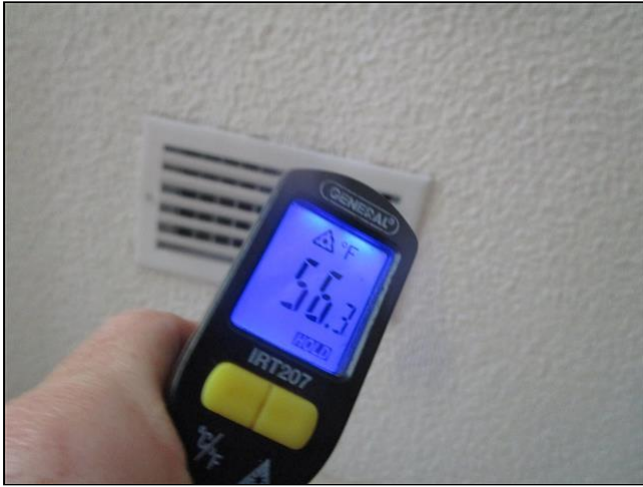
6.0 Item 2(Picture)

(2) The ambient air test was performed by using thermometers on the air handler of Heat pump in cool mode to determine if the difference in temperatures of the supply and return air are between 14 degrees and 22 degrees which indicates that the unit is cooling as intended. The supply air temperature on your system read 56 degrees, and the return air temperature was 72 degrees. This indicates the range in temperature drop is normal.

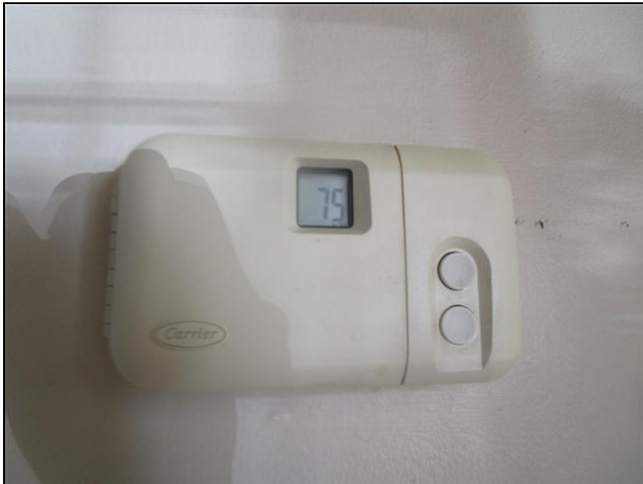
6.1 Item 1(Picture)

Thermostat is located in the hallway.

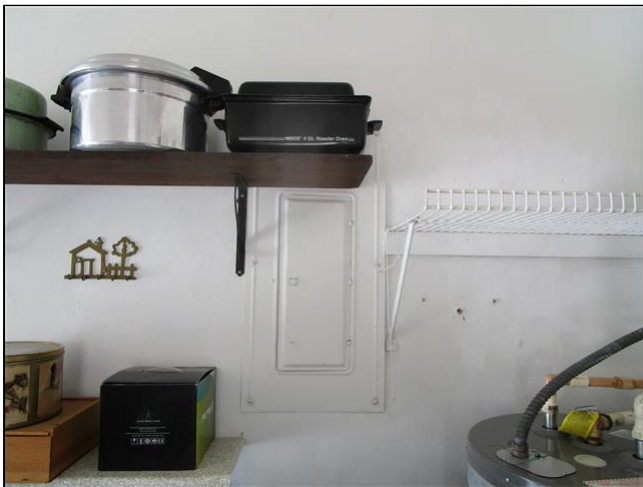
7.0 Item 1(Picture)

Main electric panel is located in the garage.

Electric sub-panel in the shed.

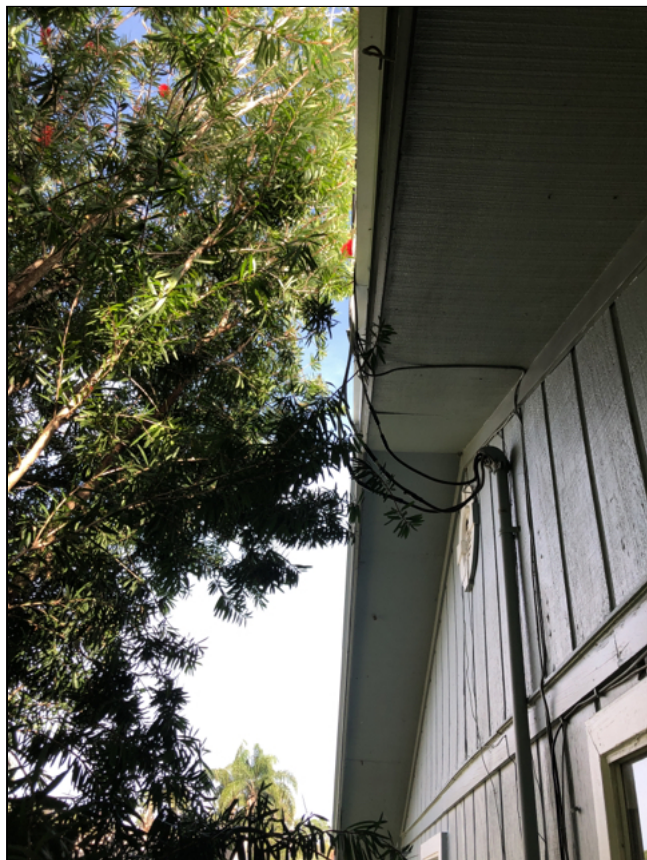
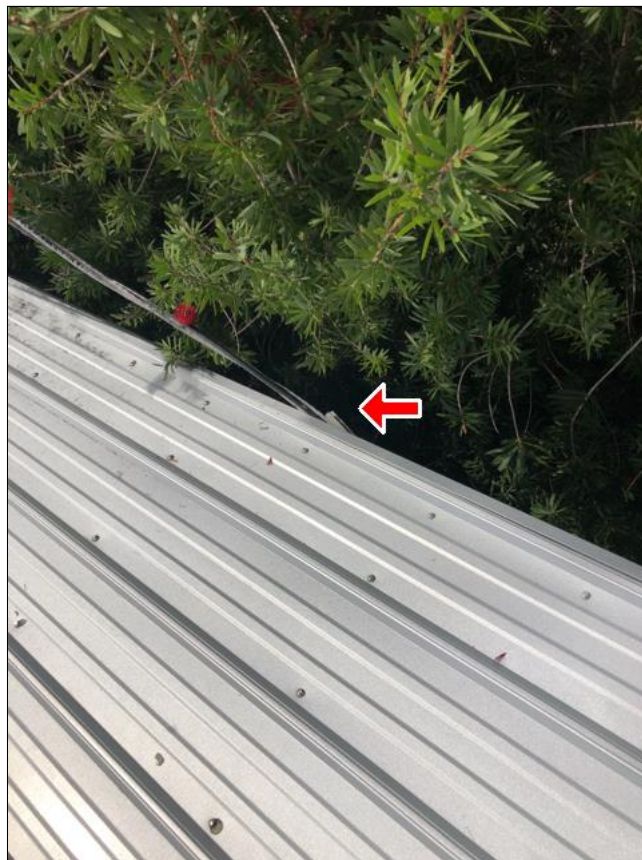
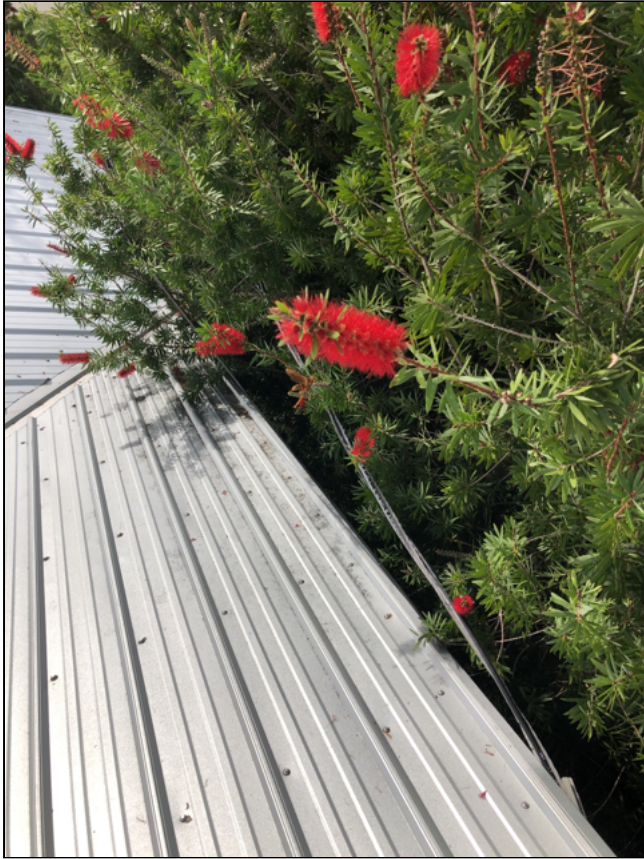
There are trees growing into the electric service lines, they should be trimmed to prevent damage.

The electrical service conductors are rubbing against the roof.

Inspector recommends further evaluation by a licensed electrician.

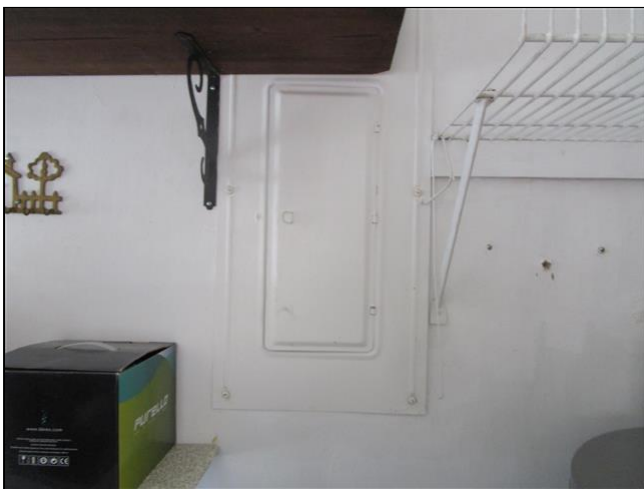
7.2 Item 1(Picture)

(1) The main electric panel had a shelf mounted in front of it. Therefore, inspector did not disassemble the shelf to inspect the electric panel.

Inspector recommends that the main electric panel be inspected prior to closing.

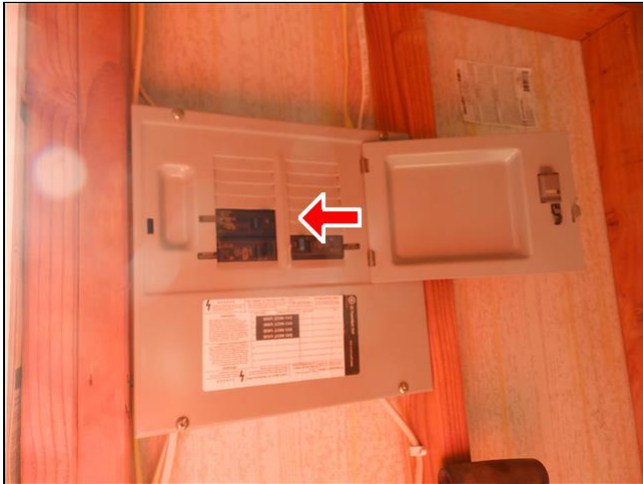
(2) At least one circuit breaker in the electric sub-panel appears to be of a different brand than panel manufacturer. The manufacturer requires that in order for the panel to be safe, only their brand is allowed to be used inside the panel. Even though these circuit breakers are all "UL approved," they are not approved to be used in panels of different manufacturers unless so indicated on the panel label.

Grounds and neutrals should be separated in the electric sub-panel.

Electrical issues should be repaired/replaced by a licensed electrician.

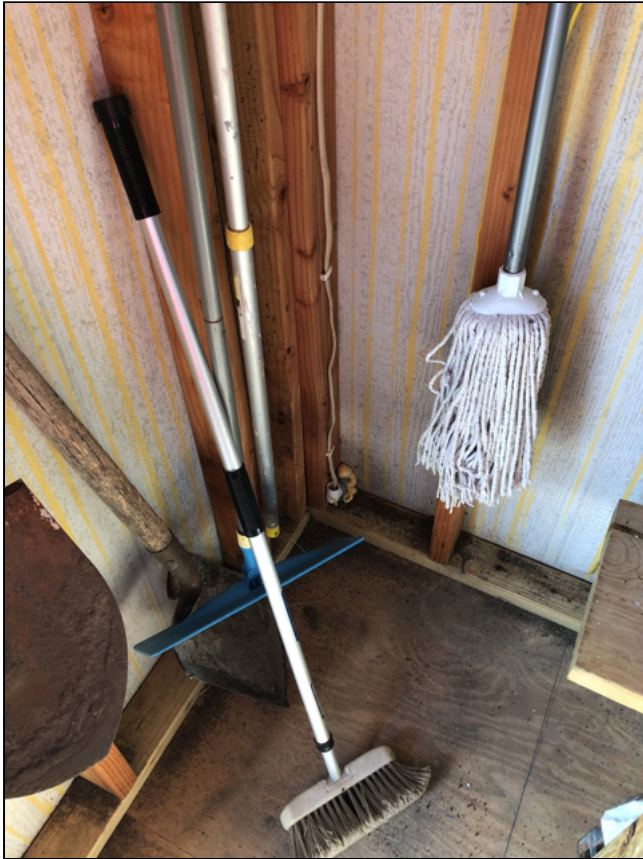
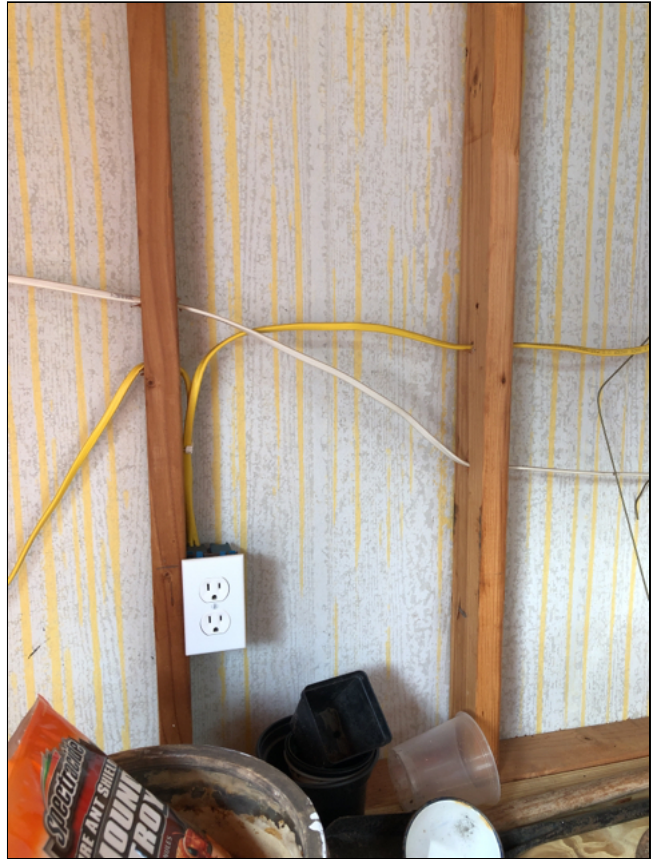
Any exterior electric conductors/wires should be protected against mechanical damage (enclosed in electric conduit) to a height of 8 feet.

Inspector recommends repairs and further evaluation by a licensed electrician.

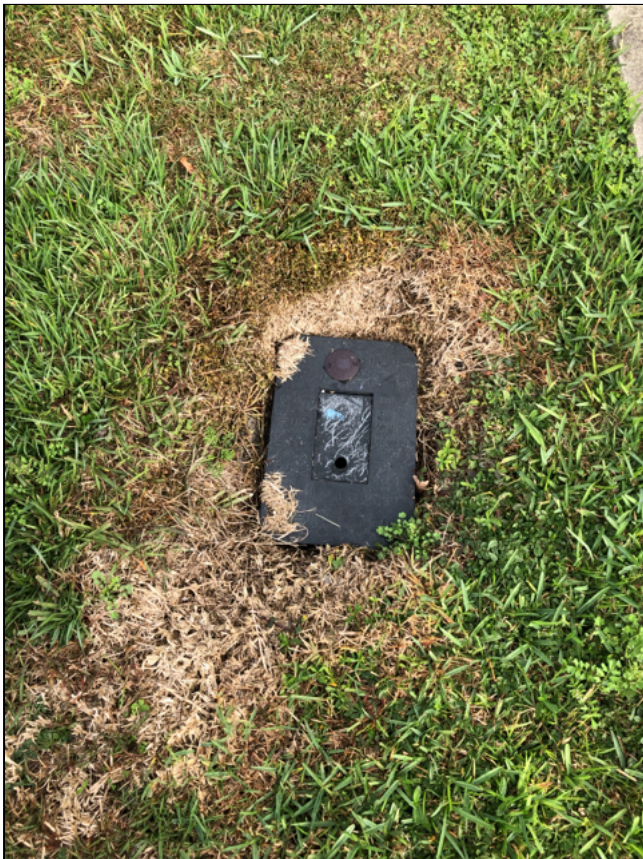
8.0 Item 1(Picture)

The main shut off is located outside in the ground by the road.

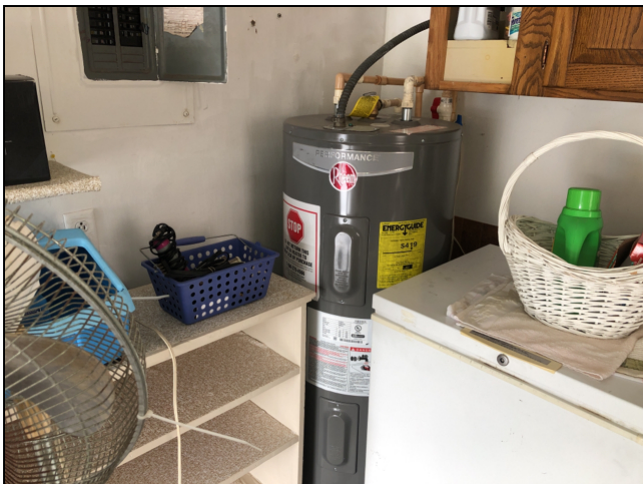
8.3 Item 1(Picture)

Water Heater was manufactured in 2018.

Life expectancy is generally 5 to 10 years. It appeared to be working properly at the time of inspection.

Serial No.	M121805173	
Model No.	XE40M06ST45U1	
Manufacture Date.	19MAR2018	
Cap. U.S. Gals.	40	
Phase	1	1
Volts AC	240	208
Upper Element Watts	4500	3380
Lower Element Watts	4500	3380
Total Watts	4500	3380

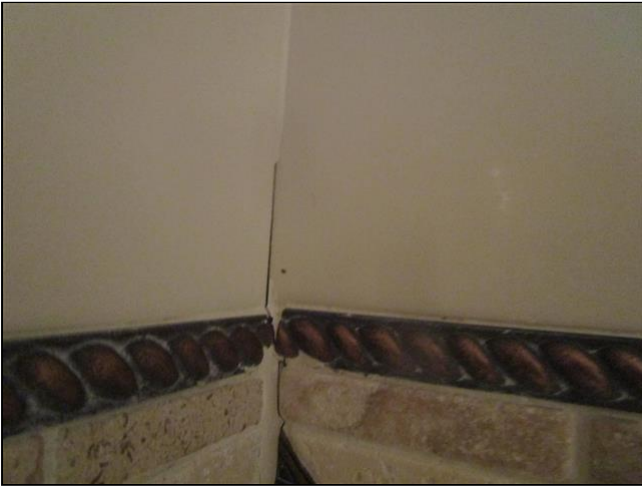
8.4 Item 1(Picture)

Cracks in the shower area can allow water intrusion and damage. Caulk or grout as needed.

Some staining inside a couple of the glass blocks in the master bath.

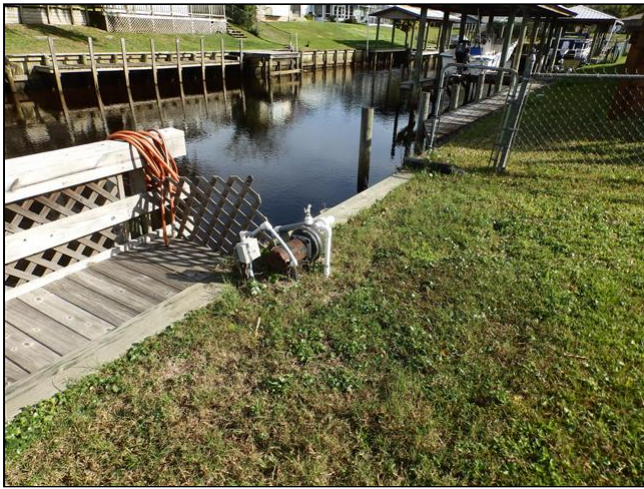
8.5 Item 1(Picture)

Water pump by the bulk head was not inspected.

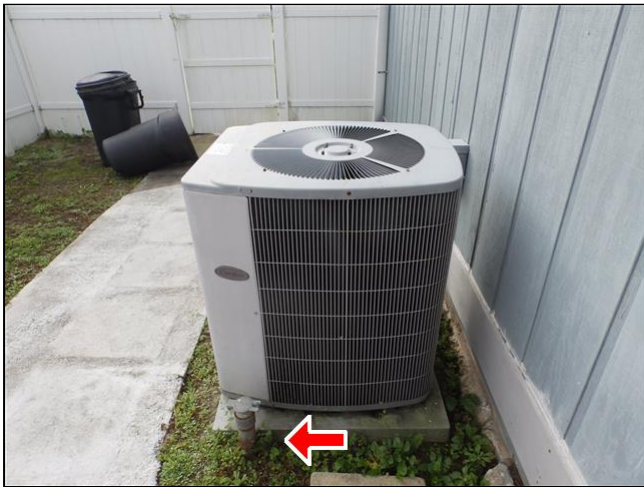
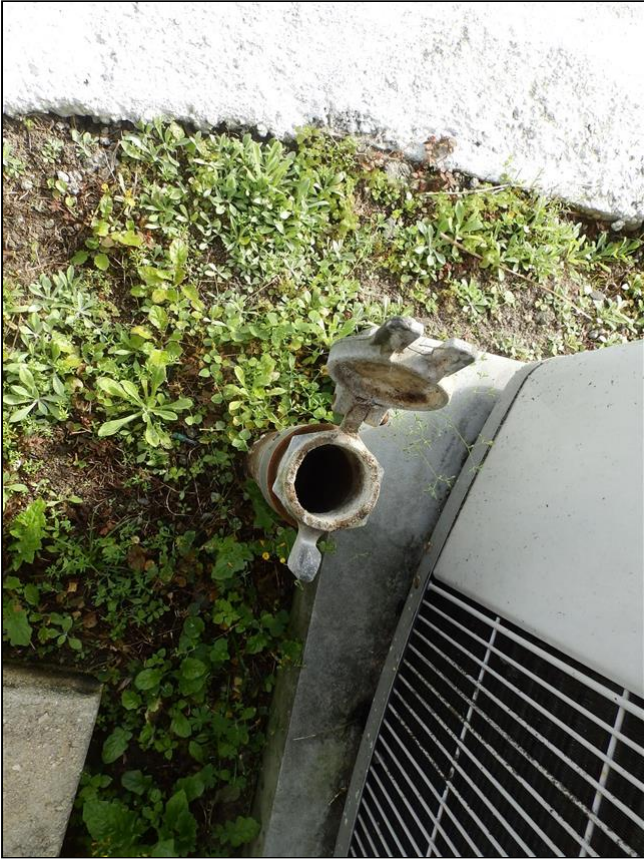
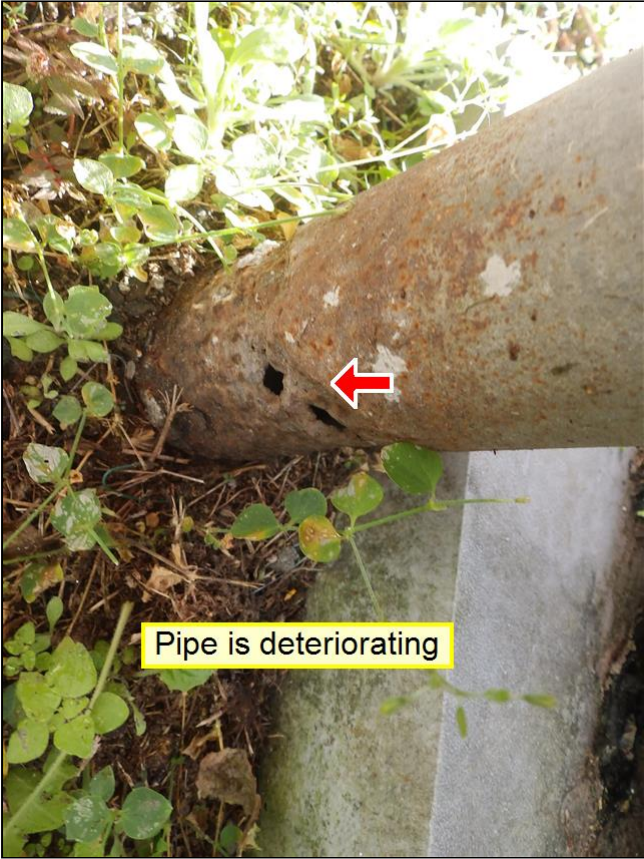
Metal cap observed. It appears to be to a buried fuel storage tank. Fuel storage tank was not inspected or the soil around it. Metal at ground level is beginning to deteriorate.

Smells like it still has fuel in it.

Inspector recommends you have further evaluation of the fuel storage tank to determine if it needs to be emptied and/or removed.

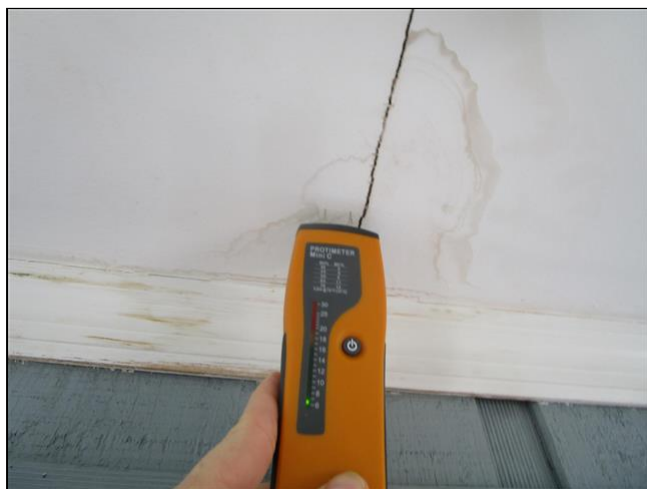
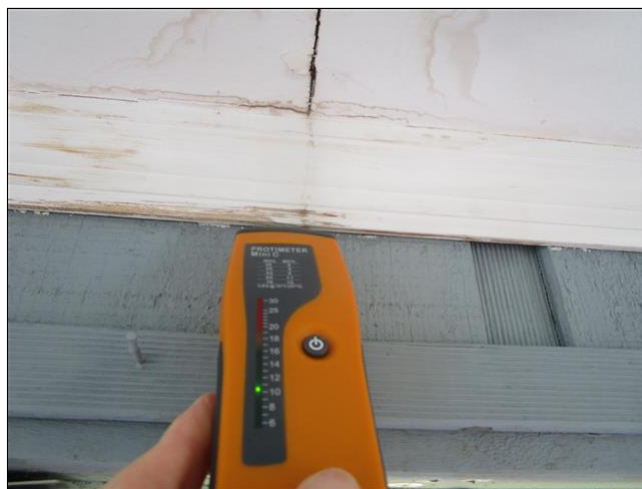
(1) There were some stains on the ceiling near the fireplace and in the florida room. No excessive moisture observed at time of inspection.

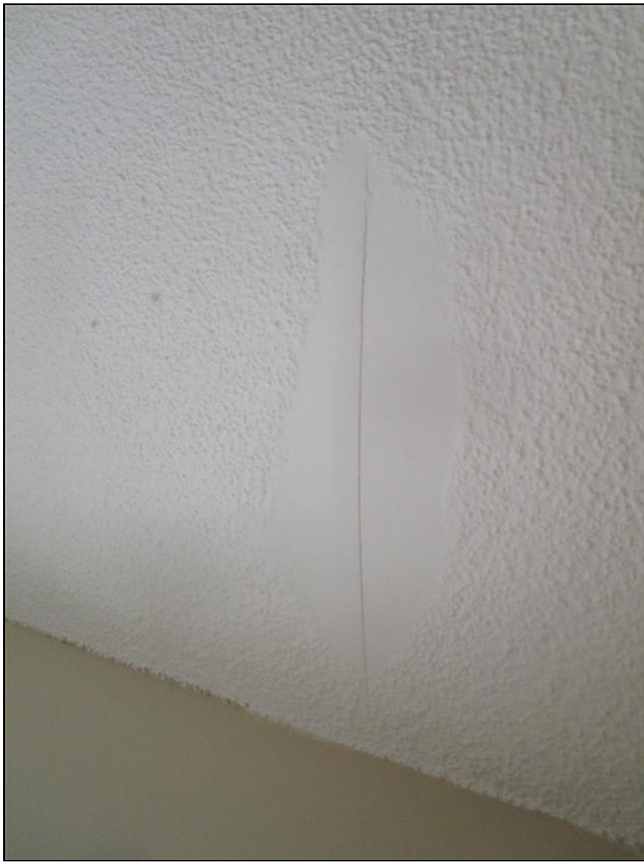
9.0 Item 3(Picture)

(2) Minor cracks on the ceiling in a couple of areas, paint or repair as needed.

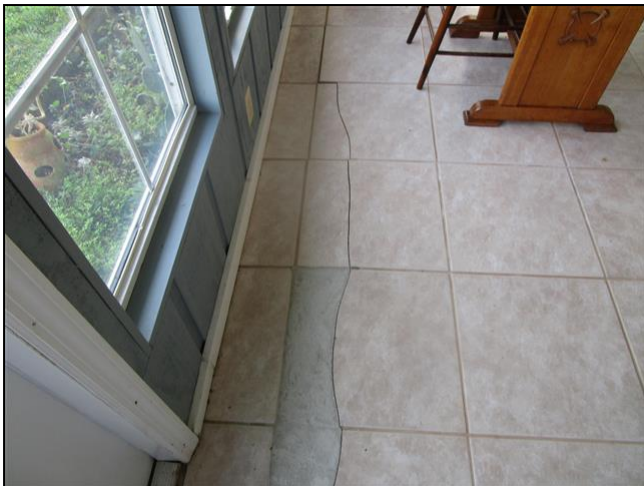
9.2 Item 1(Picture)

Foundation on the Florida room (north side) has settled. Some tiles cracked. Concrete filler.

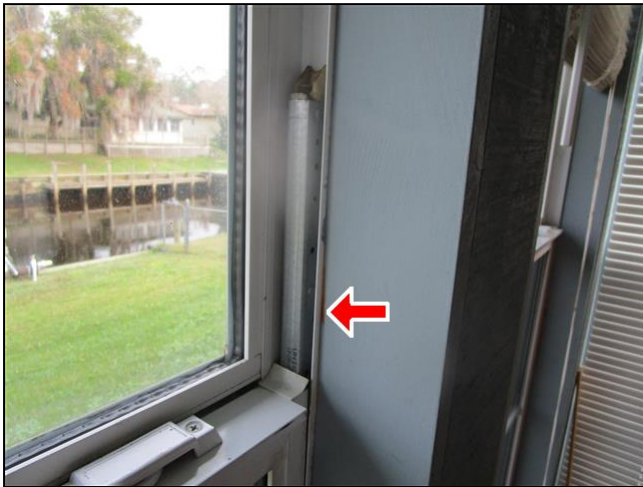
9.5 Item 1(Picture)

A few of the windows do not operate smoothly and need cleaning, adjusting, lubricating and possibly repairs.

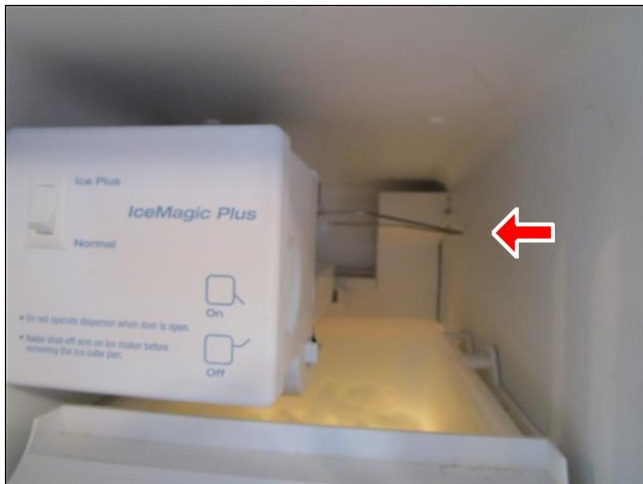
10.3 Item 1(Picture)

Ice maker was off at time of inspection and was not tested.

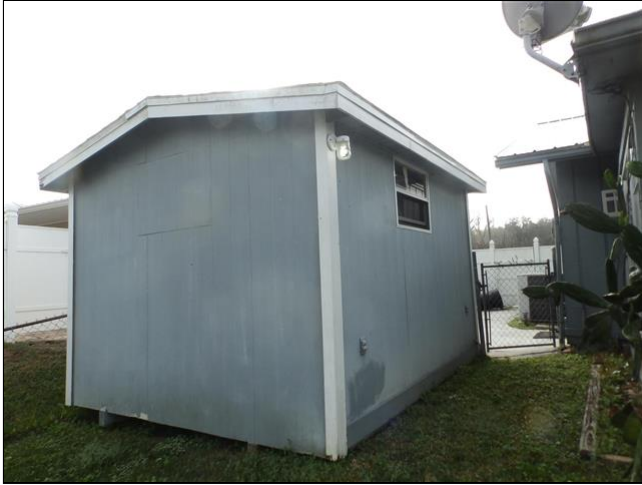
12.0 Item 1(Picture)

Hurricane straps were not observed on the out building.

Shed appears to have settled a little. Repair or replace as needed.

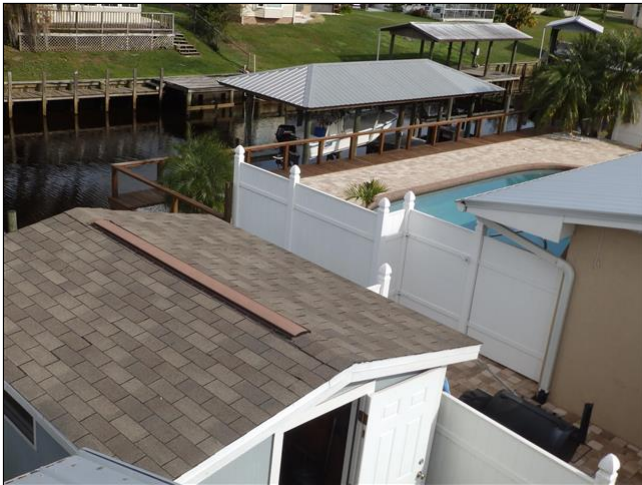
12.1 Item 1(Picture)

Picture added for general information.

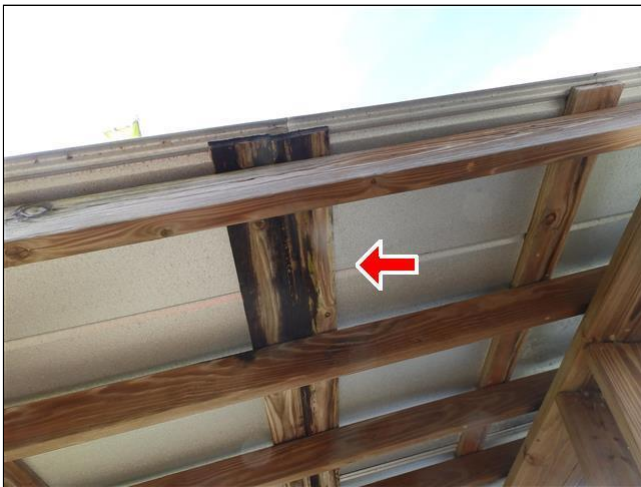
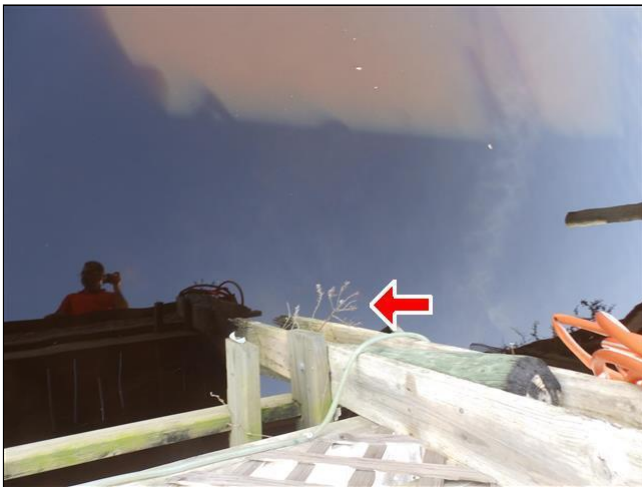
(1) Roof over the dock appears to be leaking, based on the dark wood.

A couple of the roof supports are damaged and/or loose.

Some repairs to dock observed.

Inspector recommends further evaluation by a licensed dock builder or licensed contractor.

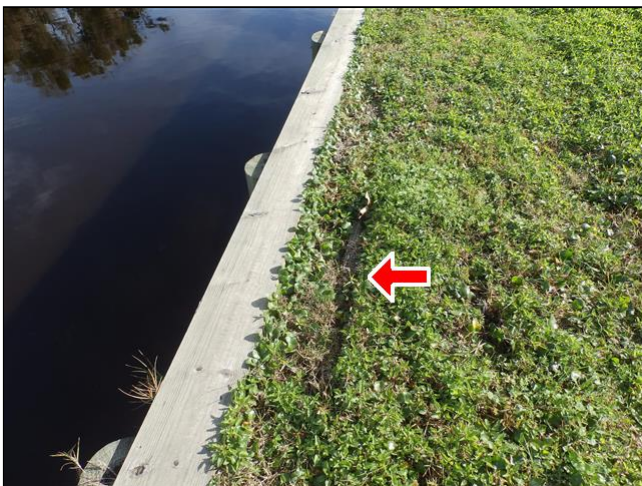
13.0 Item 8(Picture)

(2) Erosion observed near the bulkhead. May be an indication that the bulkhead is not functioning as designed. Small amount of vegetation appears to be growing through the bulk head.

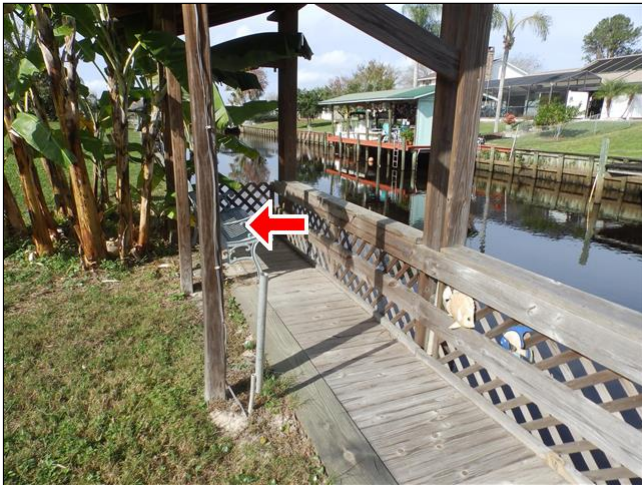
13.1 Item 1(Picture)

Any exterior electric conductors/wires should be protected against mechanical damage (enclosed in electric conduit) to a height of 8 feet.

Recommend weather proof electric outlet.

Inspector recommends repairs and further evaluation by a licensed electrician.
